Practical building defect solutions; construction failures to be avoided- Real case studies selected from Malaysian buildings

Key words: building defects, construction failures, building leakage, Malaysia.

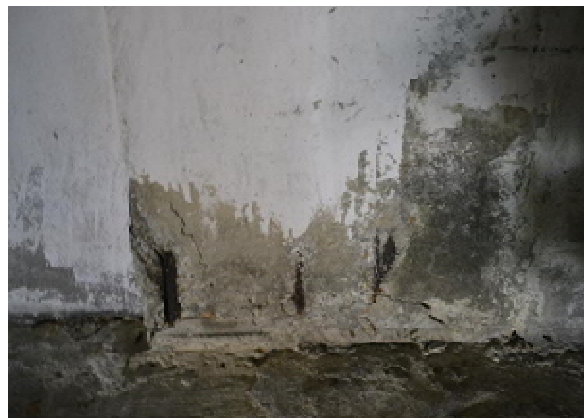
A. Concrete Surface Damage/Spalling

Why did it fail? Corrosion growth leads to concrete damage (see Fig. 1). How it could have been avoided. Corrosion of reinforcing steel can be prevent by applying a surface coating or sealer that is intended to create a barrier to the incoming contaminated water during the construction. Solutions:

Figure 1: Concrete surface damage

a. Electrochemical Technique such as cathode protection and chloride removal. Cathode protection is essentially the polarization of a metal to reduce the corrosion rate. An electrode is connected electrically with the reinforcement. This electrode becomes the anode, forcing the steel to become the cathode; halting the corrosion process.

b. Patch repairs consist of the following activities that are briefly described below:-

i. Removal of cracked and delaminated concrete to fully expose the corroded reinforcement.

ii. Cleaning of corroded reinforcement and the application of a protective coating to the steel surface (e.g. Anti-corrosion epoxy coating or zinc rich primer coat).

iii. Application of repair mortar or micro-concrete to replace the damaged concrete

iv. Possible coating or sealant applied to the entire

concrete surface reduce moisture levels in the concrete

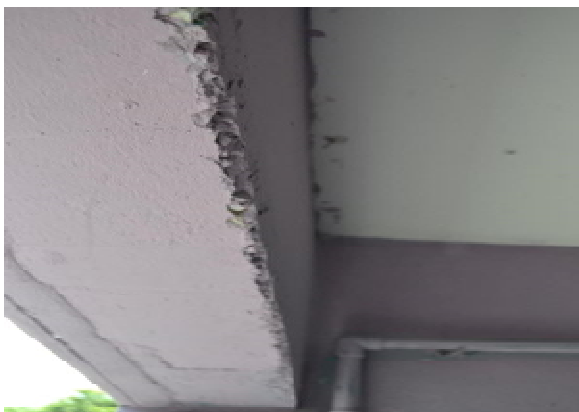
B. Honeycombing – voids in concrete caused by the mortar not filling the spaces between the coarse aggregate particles

e. Inadequate Vibration

When the concrete is properly vibrated it acts more like a liquid allowing it to better settle in the form, consolidate around the reinforcement and completely fill the forms (see Fig.2)

Figure 2: Honeycombing defect problem

Solutions:

a. If the honeycombed area is small in extent and depth does not significantly jeopardize the quality of the cover concrete protecting the reinforcement then, it can be repaired by patching with mortar of a similar color to the base concrete.

b. The extent and depth of the honeycombed area first needs to be defined. This can be done by chiseling out the affected area to expose sound concrete or by using non-destructive testing techniques such as impact-echo.

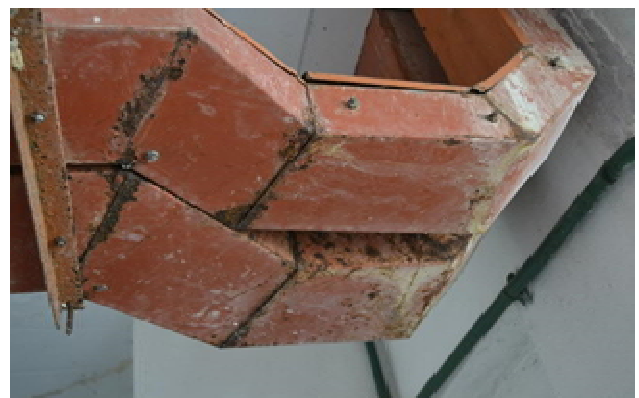
B. Corrosion on External Metal Trunking

Why did it fail? It caused by changing environment and ingress of chloride ions and carbon dioxide to the steel surface (see Fig. 3). How it could have been avoided: while the coatings on steel conduit provide excellent corrosion protection, supplementary corrosion protection may be necessary in very corrosive environments. Types of supplementary corrosion protection include paints; tape wraps, or shrinks wraps. A bitumastic coating, zinc-rich paints or acrylic, urethane or weather stable epoxy-based resins are frequently used. Surface preparation is important for proper adherence. The tube should be washed, rinsed and dried. It should not be abraded, scratched or blasted since these processes could compromise the protective zinc layer. A compatible paint primer or two coats of paint adds protection. Solutions - Rust contamination can be removed by adding one part of nitric acid to nine parts of warm water. Leave for 30 to 60 minutes, and then wash off with plenty of fresh water. Then apply applying zinc over steel to protect iron and steel from rusting.

Figure 3: Corrosion on external metal trunking

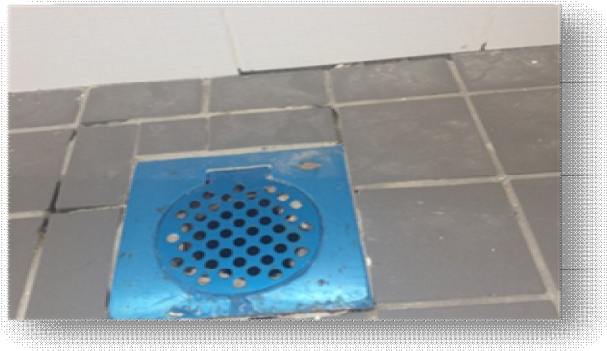
C. Grouting of Tiles - the grout around the tiles is damaged

Why did it fail? It caused by poor workmanship in the application of grout (see Fig.4). How it could have been avoided:

Figure 4: Tiles grouting improper

Solutions:

a. Install new grout.

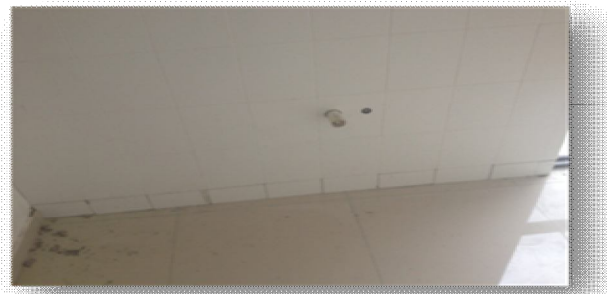
C. Uneven Tiles Lining

Why did it fail? The defect is due to human errors. The workers do not plan and estimate the tiles location properly during the lining of the tiles (see Fig.5). The tiles alignment between the wall and floor is not in a straight line. The alignment of the wall's tiles should be in a straight line with the floor's tiles.

Figure 5: Uneven tile lining

How it could have been avoided - Plan and estimate properly the location of the tiles in order to make the alignment between the wall and floor is in an even lining. Solutions - Demolished the tiles and re-locate.

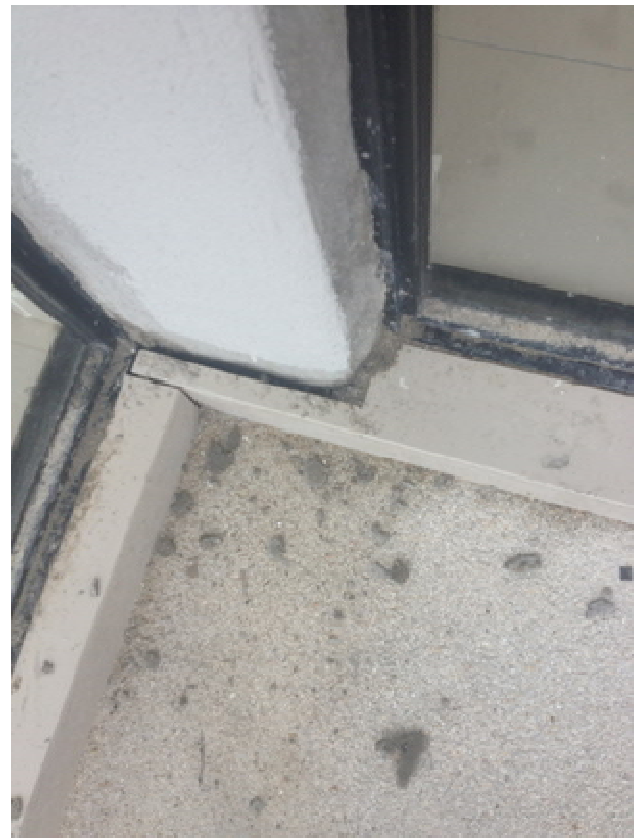
D. Gap Between Floor Tiles & Columns (Fig.6)

Why did it fail? It caused by poor workmanship. How it could have been avoided- simply by installing a baseboard. Solutions - Improve workmanship's skill.

Figure 6: Gaps between floor base and column

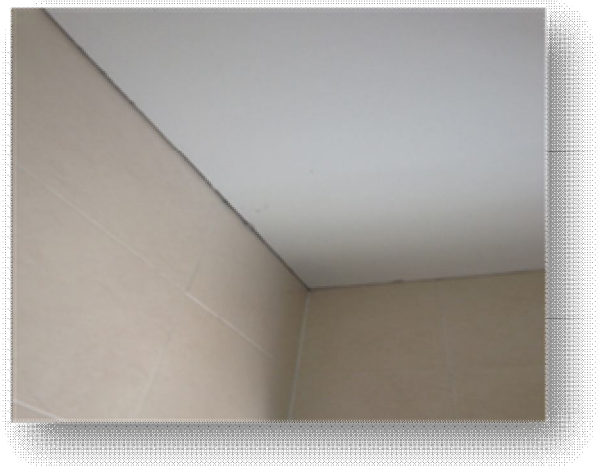
E. False Ceiling - gap between ceiling and wall

Why did it fail? Poor workmanship, do not measure the size of ceiling accurately. How it could have been avoided -Measure the size of ceiling accurately. Solutions: Install crown molding.

Figure 7: Gap between wall and ceiling

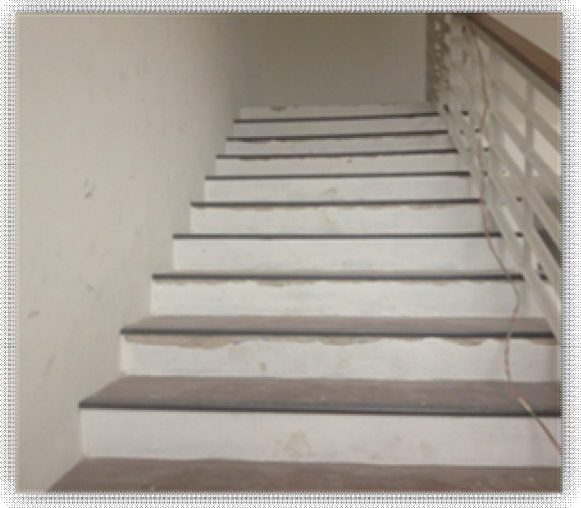
F. Defective Plastered Rendering

Why did it fail? The plastered renderings are deteriorated and look unevenly (see Fig. 8) due to:

- a. Poor workmanship.
- b. Shrinkage or movement in the substrate.

Figure 8: Defective plastered rendering

Solutions - Reapply the plastered rendering uniformly.

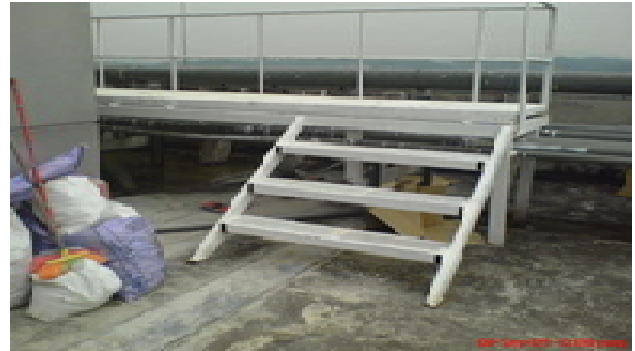
A. Leakage Flat Concrete Roof Slab

Why did it fail? Flat concrete roof leaking found at joints, steel staircase support and various concrete cracks (see Fig. 9). How it could have been avoided. To rectify this roof leakage from happening:

Figure 9: Leaking on the surface of the concrete flat roof

1. To do proper waterproofing rectification treatment to all the cracked leakage area. Typical effective procedure is to do the following steps (see photos on the right-Fig. 9):

2. Hacking the concrete floor.
3. Applying waterproofing cement with fiber.
4. Cement render until floor finish.

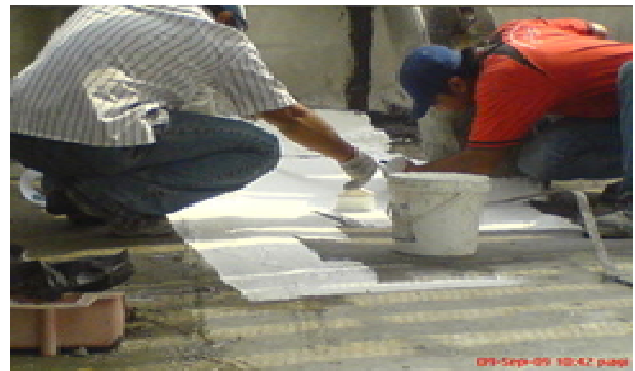
Figure 10: Rectification done by applying cementitious epoxy coatings

5. Applying waterproofing cementitious liquid on finish concrete (see Fig. 10).

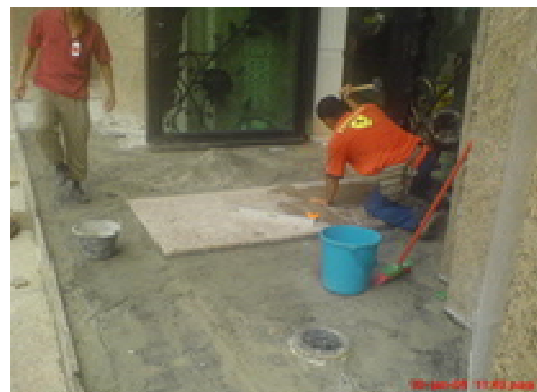
B. Exterior Marble Floor Replacement

Why did it fail? Imported floor marble used at the front entrance cracked (Fig.11). How it could have been avoided-Require proper entrance cover to avoid rain water and direct sun heat; possible to get the marble cracked. To rectify this marble cracked from happening:

Figure 11: Exterior marble floor replacement

1. Having proper entrance cover.
2. Avoid using imported marble as it difficult to secure.
3. Successfully use local marble to match existing color.

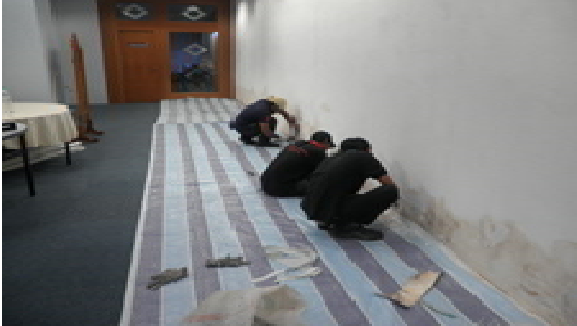
C. Lower Portion Interior Wall Stained

Why did it fail? It happened when the opposite side of this brick wall having wet areas i.e. planters box and toilets (see

Fig. 12). How it could have been avoided- Ensure proper water proofing done right. If not, this ugly stained effect appears on bright color internal wall. Internal rectification works can be done as follows:

Figure 12: Part of the internal wall (lower side) stained
D. Stalactite Appearance

1. Smooth off the peeled surface completely.
2. Apply waterproofing special cement on the leak surface.
3. Apply water proofing paint coat with matching color.

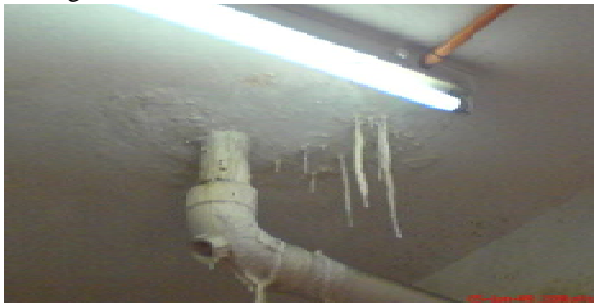
Why did it fail? Timely water leakage through concrete floor due to the above wet area not having proper water proofing installed. In this case it fails inside a motor room located next to the light spot (Fig.13). How it could have been avoided - Avoiding having potential wet area such as the flat roof, planter's box, concrete gutter or toilet located above the mechanical or electrical room of a building. To rectify this leakage from happening again:

Figure 13: Stalactite appearance

1. Do the below of concrete floor treatment by first cleaning-up the work surface.
2. Injecting water proofing epoxy grouting using high pressure injecting machine (Fig.14).
3. After the grouting exercise, ensure to paste-on the water proofing cement.

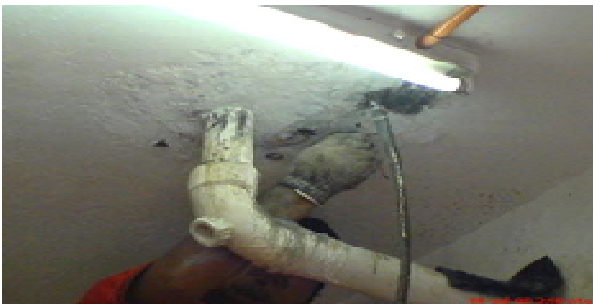
Figure 14: Grouting process method being done

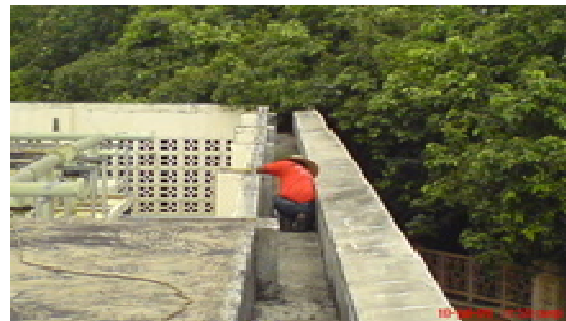
E. Concrete Gutter Clogging

Why did it fail? It caused by clogging off the concrete roof gutter resulting rain water leak to internal as well as to the external of the building (see Fig.15). How it could have been avoided - First, the planting of the trees located quite closely with the flat roof building. The leaves from these tree easily clogging the RWDP. Next, the small size of water outlet/RWDP unable to cater the rain water flow from the big size of the concrete gutter. To rectify this marble cracked from happening:

Figure 15: Clogging off concrete gutter

1. Having bigger size of water outlet/RWDP to cater water flow.
2. Avoid plants big tree species with a lot of leaves near a flat roof building.
3. Good point for this building having comfortable size of concrete gutter for maintenance worker to fit-in doing the maintenance work.

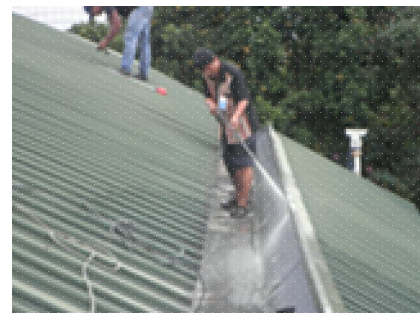
F. Metal Gutter Leakage from not-functioned epoxy

Why did it fail? Metal gutter require more maintenance as it's rubberized/epoxy joint not expanding and contracting vice-versa hence letting leakage to occur (Fig. 16). How it could have been avoided - Require proper maintenance and regular cleaning and replacing the epoxy and peeled-off rivet.

Figure 16: Leakage at joints of metal gutter

To rectify this problem from happening:

1. Ensure to water-jet the existing gutter, having super clean surface.
2. Take-off the old epoxy and replace with new one. Application better in clear weather to ensure epoxy properly fit and function (Fig.17).
3. Successfully replace peeled-off rivet with new one at the joints.

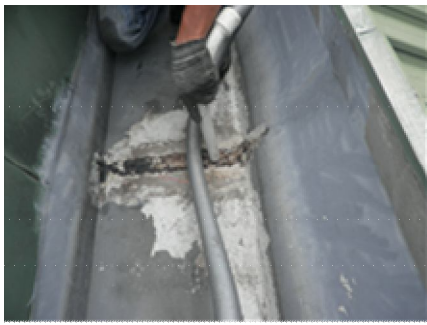
Figure 17: Replacing the epoxy at the joint being done

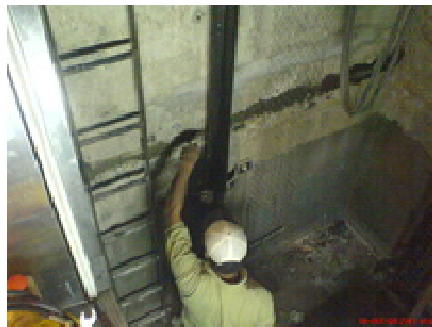
Why did it fail? Unable to use the lift as it is leaked/fill with water due to the leakage high ground water table pressure (see Fig.19). How it could have been avoided - Require to exercise total specialize water proofing rectification work on the leakage wall area. Water normally seeping through the cracked/weak spots on concrete wall. To rectify this problem from happening:

Figure 18: Water seepage at the lift pit wall due to high water table

1. Require to drill and hacking the leakage cracked area.
2. To drill-in water plug to stop water leak (see Fig.18).
3. Also to use waterproofing cement to render the crack area.

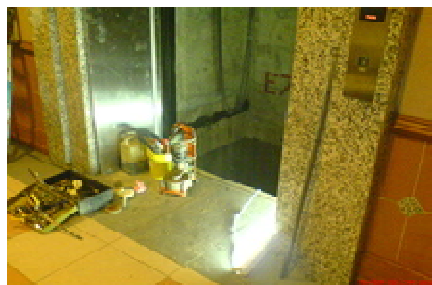
G. High Ground Water Table level at Lift Pit

Figure 19: External view of the lift pit- to be closed for rectification work
