Selected Melaka Malay traditional houses: comprehensive analysis on building defects, failures and solutions

1. MR ABDULLAH BIN MANSUR'S HOUSE

2. MR BUJANG SIAM'S HOUSE

3. TUAN HAJI HUSSIN BIN LAJIS'S HOUSE

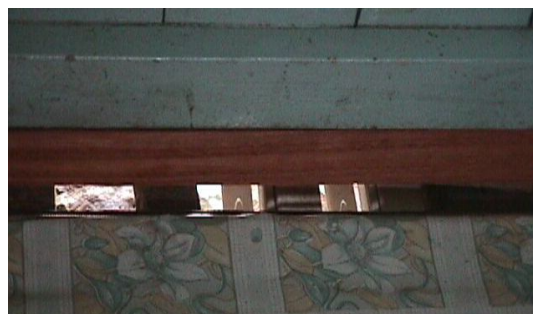
a. Refer to Figure 1(a), it was found that the joining of the floor was untidy and this situation has caused the floor to not firmly or tightly fixed in place. The floor boards were able to be detached from the fixed position.

Figure 1(a): Untidy floor joining

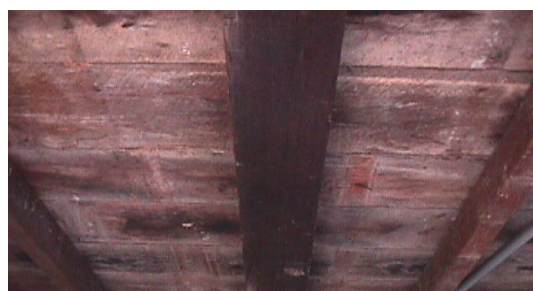
b. As in Figure 1(b), it can be seen that the colour of the wood surface has faded. This defect occurred due to lack of maintenance by the building occupants.

Figure 1(b): Faded wood surface colour

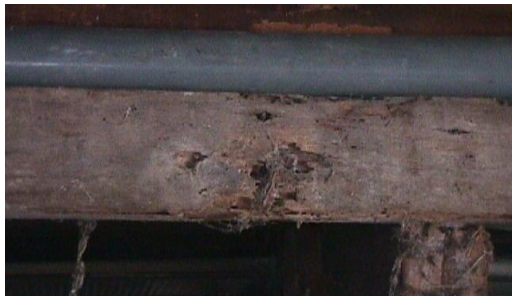
a. Refer to Figure 2(a), floor girders or also known as joists, which functioned as floor supports were rotting. This defect was caused by termite infestation.

Figure 2(a): Rotted floor girders

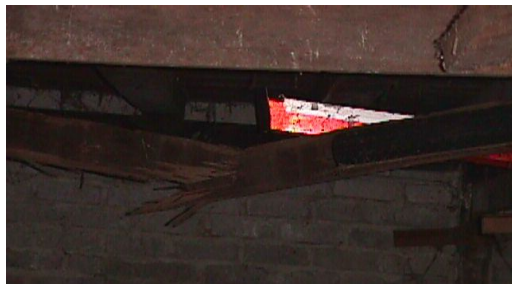
b. As in Figure 2(b), the floor girders were broken due to the heavy use and tear of the space.

Figure 2(b): Broken floor girders

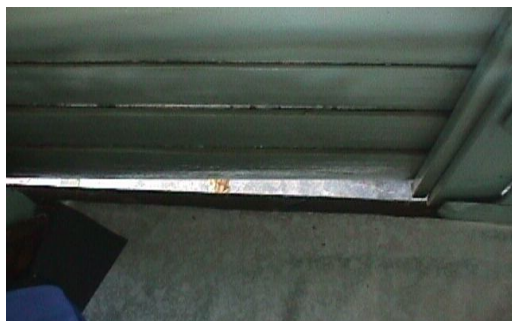
a. Refer to Figure 3(a), the problem of poor installation between floor boards and wall in the porch area has caused a gap between the joining.

Figure 3(a): Gap between floor and wall

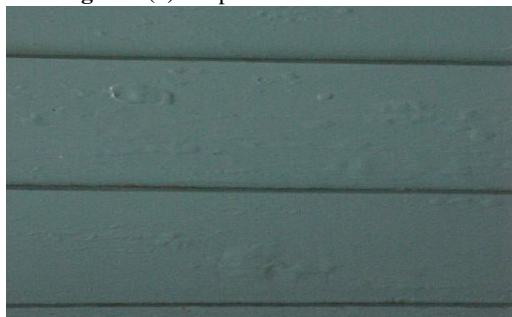
b. As in Figure 3(b), the paint surface was bulging due to incorrect use of technique during finishing sweeps.

Figure 3(b): Bulging paint surface

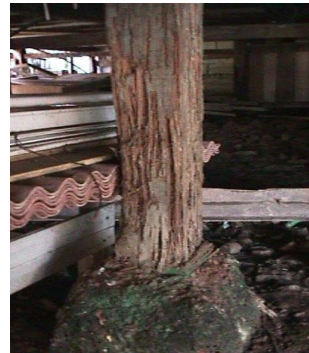
a. Refer to Figure 4(a), the pillar at the exterior of the house decayed due to absorption of water during high tide and rain.

Figure 4(a): Rotted pillar

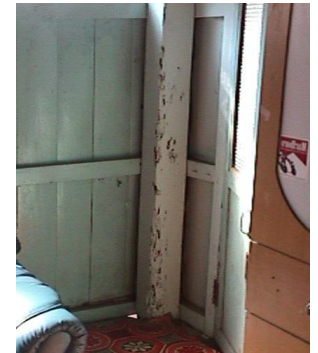
b. As in Figure 4(b), the pillar at the passageway that connects the kitchen to the main house rotted due to termite infestation.

Figure 4(b): Rotted pillar

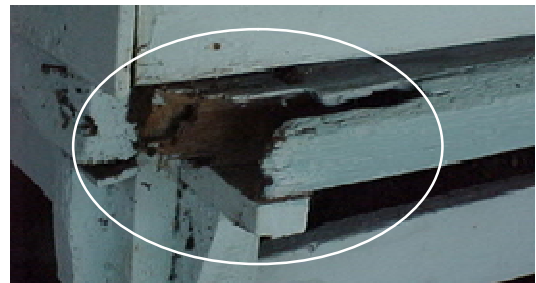
a. Refer to Figure 5(a), the sill, which is a wooden beam encircling the outer regions of the floor of the house, forming a frame or 'bulkhead' for the floor, rotted due to exposure to hot weather and rain over a long period of time.

Figure 5(a): Rotted sill

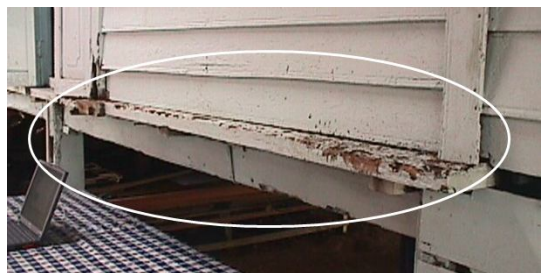
b. As in Figure 5(b), the sill on the side of the house rotted as well. This defect was caused by the exposure to extreme heat and rain for a very long duration.

Figure 5(b): Rotted sill

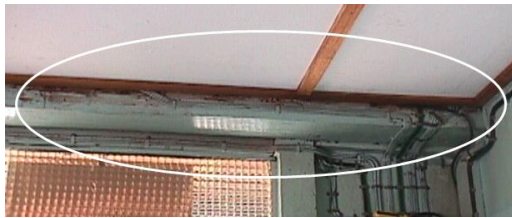
a. Refer to Figure 6(a), the roof crossbeam of the main house was rotted as a result of termite infestation.

Figure 6(a): Rotted roof crossbeam

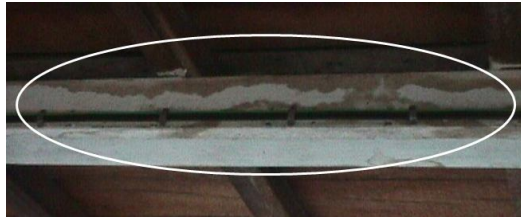
b. As in Figure 6(b), water stains were seen on the roof beam as an effect of water absorption from the leaking roof.

Figure 6(b): Water stains on roof beam

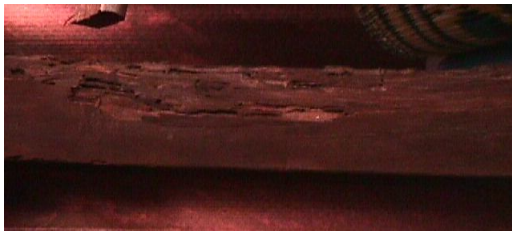
a. Refer to Figure 7(a), the roof rafter in the attic was severely damaged as a result of termite infestation.

Figure 7(a): Damaged roof rafter

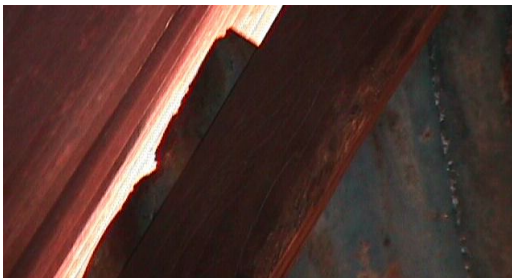
b. As in Figure 7(b), the rotted main rafter was caused by termite attack.

Figure 7(b): Rotted main rafter

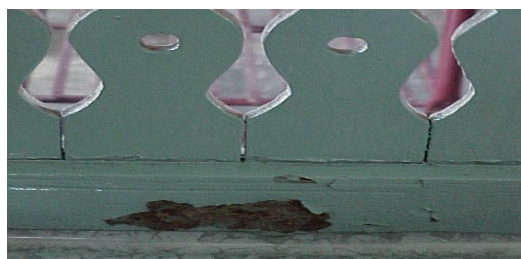
a. Refer to Figure 8, some parts of the window frames were rotted due to termite infestation.

Figure 8: Rotted window frame

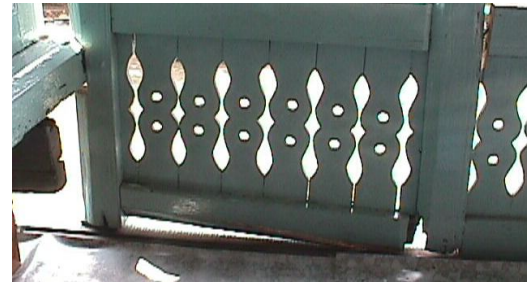
a. As in Figure 9, the baluster was not properly joint to the floor on the house porch causing gap between the connections.

Figure 9: Improperly joint baluster

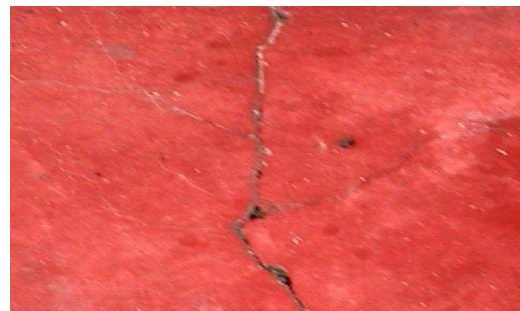
a. Refer to Figure 11(a), the floor apron has cracked as a result of heavy usage by the occupants.

Figure 11(a): Cracked floor apron

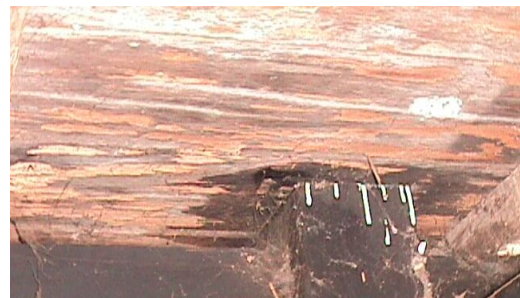
b. As in Figure 11(b), it can be seen that the floors were rotting which was caused by termite infestation.

Figure 11(b): Rotted floor

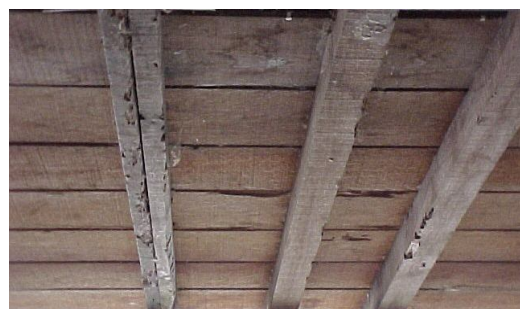
a. Refer to Figure 12(a), the floor girders were rotted due to termite infestation.

Figure 12(a): Rotted floor girders

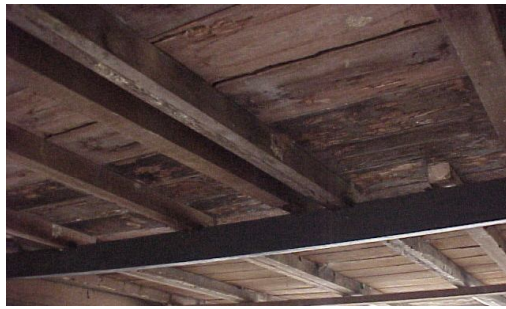
b. As in Figure 12(b), it can be seen that the girders and floor boards have been destroyed due to termite attack.

Figure 12(b): Destroyed girders and floor boards

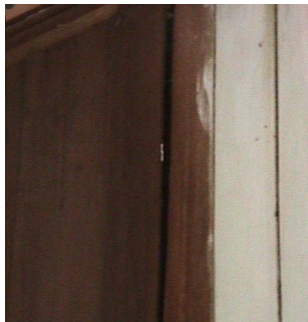
- a. Refer to Figure 13(a), the wallboard has ruptured as a result of heavy usage by the building occupants.
- b. The ledge or lath has decayed due to termite infestation.
- c. As in Figure 13(b), it can be seen that mould and fungus grew on brick wall due to exposure to moisture.
- d. Brick wall became mossy as a result of water absorption from the kitchen.

Figure 13(a): Ruptured wall

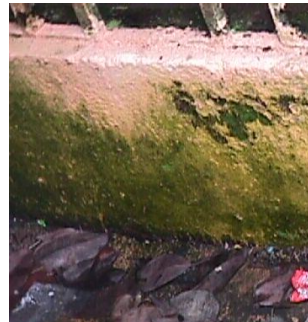
Figure 13(b): Mossy brick wall

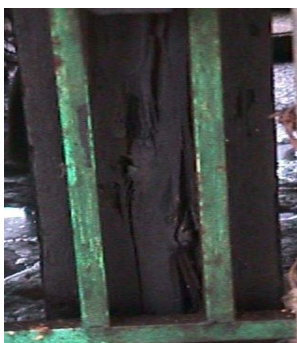
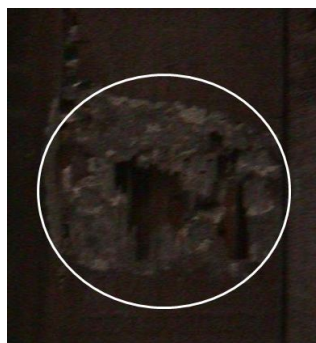
- a. Refer to Figure 14(a) and 14(b), it was found that both the deteriorated pillars were due to termite infestation, causing holes on the surface of the wooden pillar.

Figure 14(a): Decayed pillar

Figure 14(b): Decayed pillar

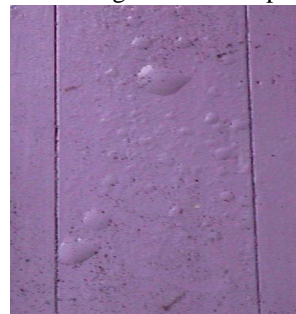
- a. Refer to Figure 15(a), the paint surface on the timber window frame was bulging.
- b. As in Figure 15(b), it can be seen that the timber ram in

Figure 15(a): Bulging paint

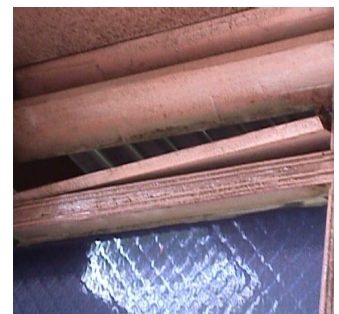
the roofing ventilation space was broken.

Figure 15(b): Broken timber

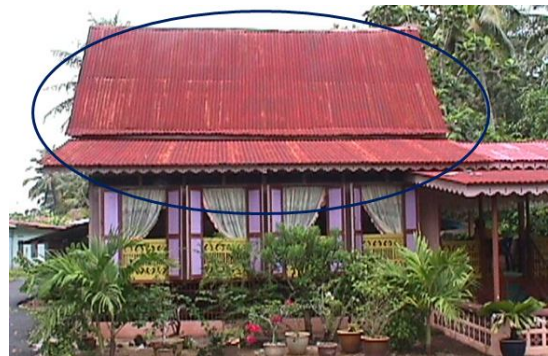
- a. Refer to Figure 16(a), the whole finishes of the roof which was made of zinc was rusted as a result of weathering factor.
- b. As in Figure 16(b), the colour of the paint on the surface of the “tebar layar”, which means “sailed ready” for roofing ventilation, has faded due to exposure to weathering factor.
- c. Refer to Figure 16(c), dirty stains are found on the roof rafters due to infiltration of rain water at the porch area.
- d. As in Figure 16(d), it can be seen that the wood surface on the ridge of the house was peeling due to splash of rain.

Figure 16(a): Rusted zinc roof

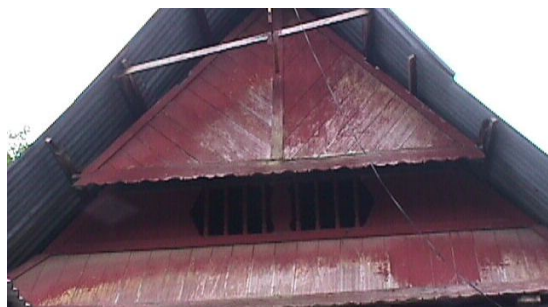
Figure 16(b): Faded paint surface

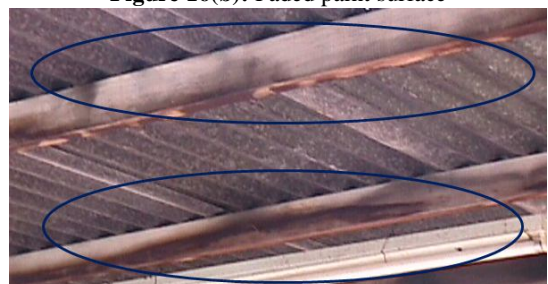
Figure 16(c): Dirty stains on rafters

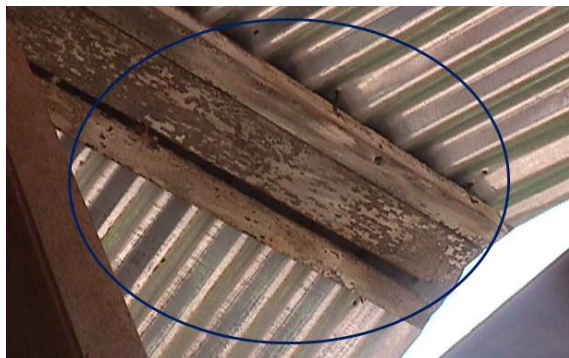
Figure 16(d): Peeling wood surface

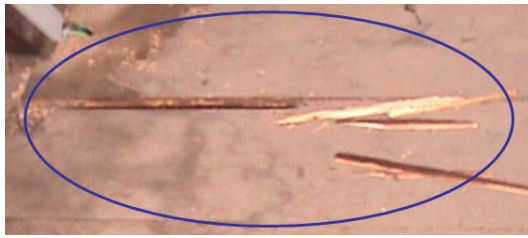
a. Refer to Figure 18(a), the floor boards were broken and decayed due to infiltration of rainwater from the leaking roof.

Figure 18(a): Broken floor boards

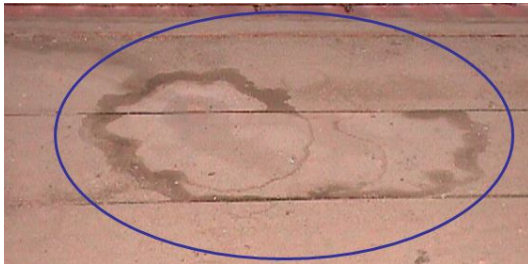
b. As in Figure 18(b), water stains were found on the floor boards in the attic as a result of a leaking roof.

Figure 18(b): Water stains on floor boards

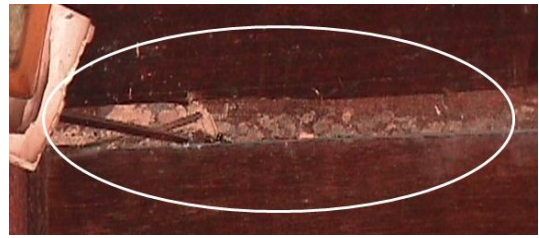
c. Refer to Figure 19(c), the wood panels were rotting which were caused by termite infestation.

Figure 19(c): Rotted wood panels

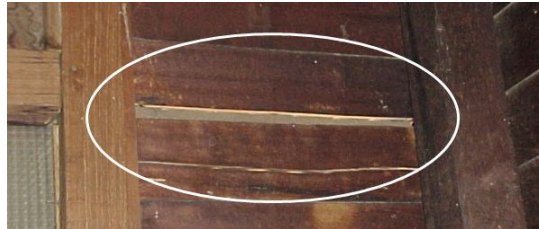
d. As in Figure 19(d), the wood panels have broken due to nailing work on the walls by the users of the building.

Figure 19(d): Broken wood panels

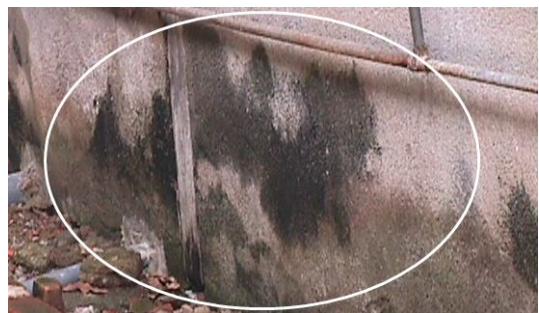
e. Refer to Figure 19(e), stains of dirt and moisture were seen on the wall due to absorption of water from the bathroom.

Figure 19(e): Stains on wall

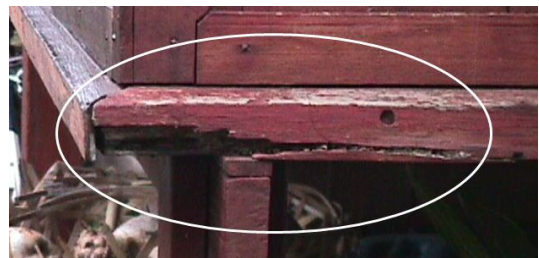
f. As in Figure 19(f), the sill wood were rotted caused by the exposure to weathering factor.

Figure 19(f): Rotted sill wood

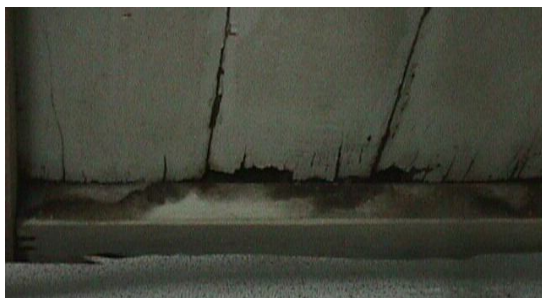
a. Refer to Figure 19(a), the wood panelling on the walls were dirty due to water absorption when the roof leaks.

Figure 19(a): Dirty wood panelling

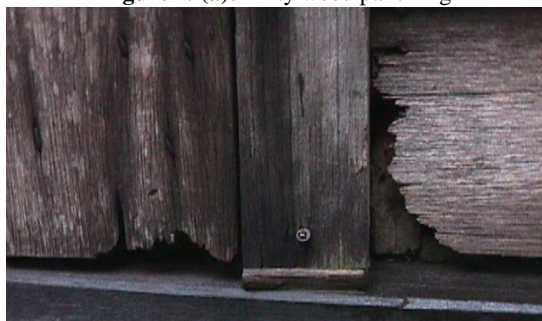
Figure 19(b): Crumbled walls and faded paint

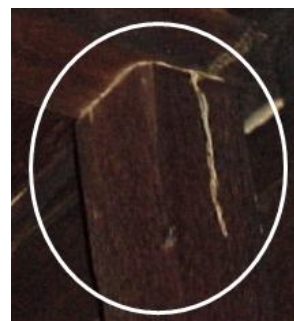
a. Refer to Figure 20(a), the pillar were rotting due to termite infestation.

Figure 20(a): Rotted pillar

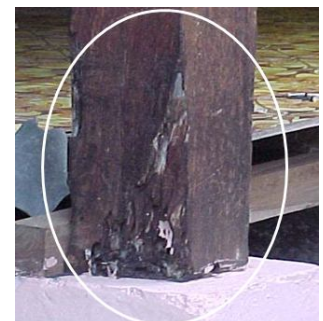
b. As in Figure 20(b), the rotted pillars were caused by constant exposure to weathering factor.

Figure 20(b): Rotted pillar

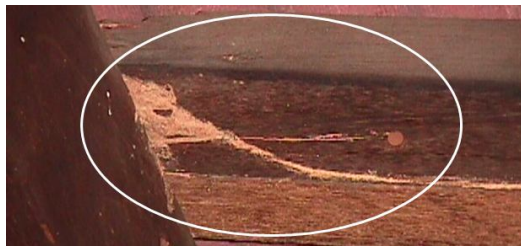
Figure 22(a): Destroyed rafter connections

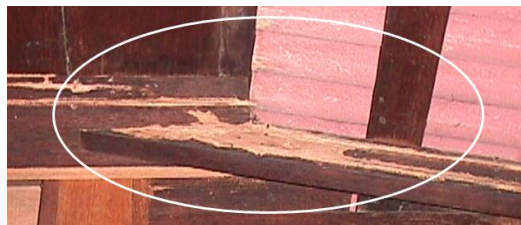
Figure 22(b): Rotted main rafter

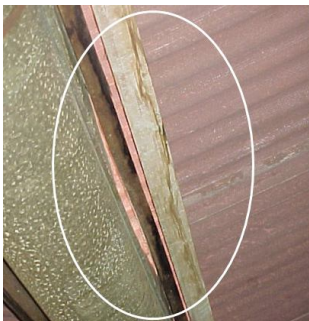
c. Refer to Figure 22(c), the rain gutter was leaking.

Figure 22(c): Leaking rain gutter

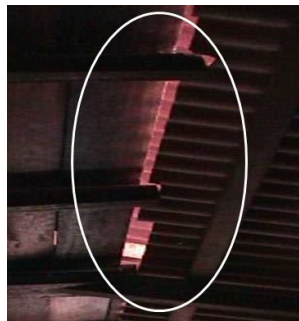
d. As in Figure 22(d), the joining of the roof finishes which did not follow the exact specification has led to roof leaks when it rains.

Figure 22(d): Leaking roof

1. Installation of roof finishes must be carried out again in accordance with specifications.
2. All damage and decay on columns, walls, crossbeams, roof rafters, wood panelling on the walls and rain gutter need to be replaced with similar materials according to the original specification or using better materials.
3. Paint the entire building with appropriate finishes which are able to withstand the surrounding weather.
4. Addition of installation of spreading shades in the kitchen area to avoid the splashing of rain water when it rains.
5. Limit the use of rubber mats in certain spaces so that any problems on the floor can be easily checked often, while avoiding moisture being trapped under the rubber mat.
6. Carry out termite attack treatment on the whole building.

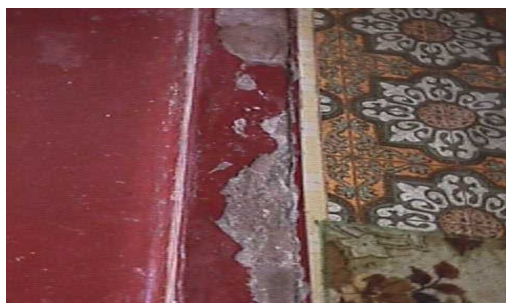
a. Refer to Figure 24(a), the cement render surfaces were ruptured and detached from the fixed positions which were caused by wear and tear factor.

Figure 24(a): Ruptured cement render surface

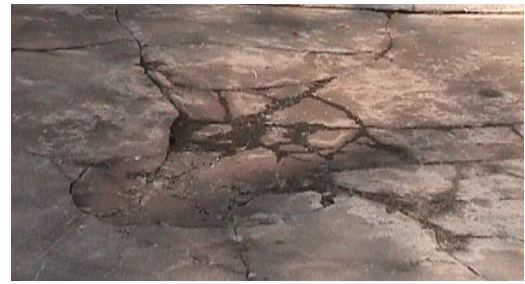
b. As in Figure 24(b), the floor apron has cracked because of the factor of heavy usage by the users.

Figure 24(b): Cracked floor apron

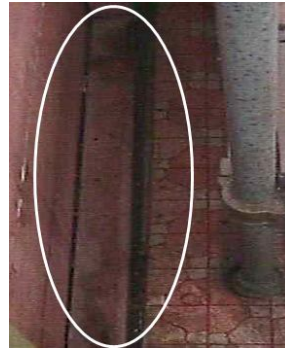
c. Refer to Figure 24(c), the faded colour of wooden floor was due to the leaking roof element.

Figure 24(c): Faded floor

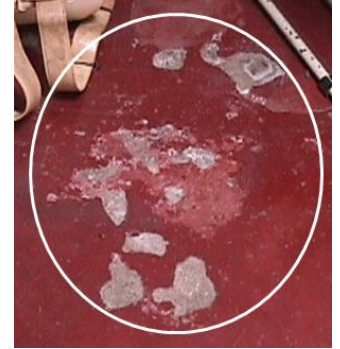
d. As in Figure 24(d), it can be seen that the cement render surfaces were ruptured and potholed as a result of wear and tear factor by the building occupants.

Figure 24(d): Potholed surface

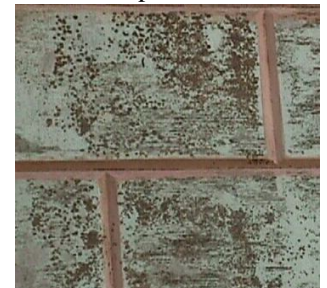
b. As in Figure 25(b), it can be seen that the peeling paint finishes were caused by the exposure to hot surrounding weather and rainy environment.

Figure 25(b): Peeling paint

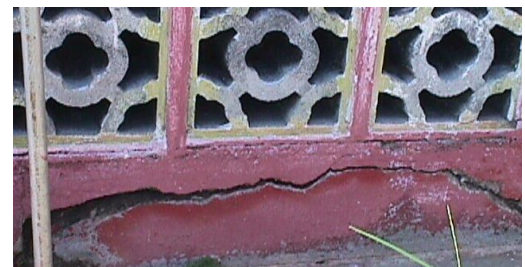
c. Refer to Figure 25(c), the wall surface on the vault was cracked, due to the vibration of the road nearby.

Figure 25(c): Cracked wall surface

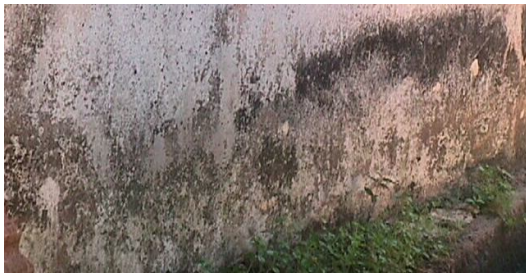
d. As in Figure 25(d), the dirty stains can be seen on the wall surface as a result of exposure to weathering factor.

Figure 25(d): Dirty wall surface

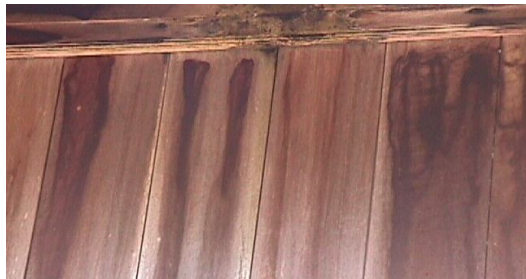
Figure 25(e): Faded timber colour

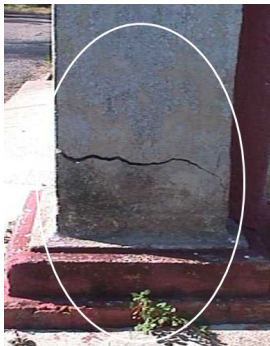
a. Refer to Figure 26(a), the cracked pillar was due to the vibration from the road nearby.

Figure 26(a): Cracked pillar

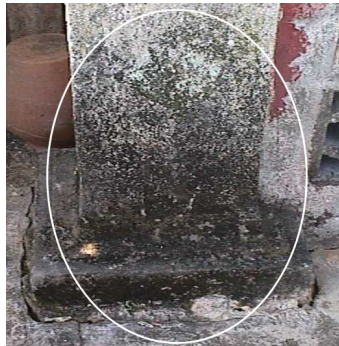
b. As in Figure 26(b), the surface of the pillar is dirty because of the constant exposure to the surrounding weather and lack of maintenance by the building occupants.

Figure 26(b): Dirty pillar surfaces

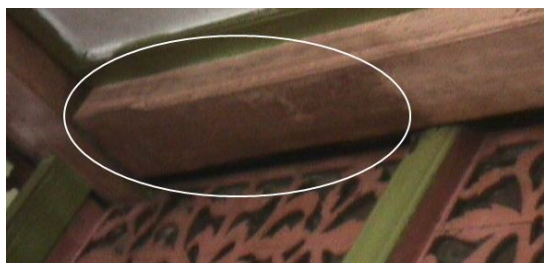
a. Refer to Figure 27(a), dirt was seen on the surface of the roof beam because of roof leaks.

Figure 27(a): Dirty roof beam

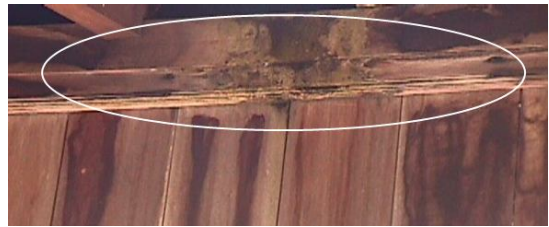
b. As in Figure 27(b), the colour of the wooden roof beam has faded as a result of water absorption during the rain.

Figure 27(b): Faded colour of wooden roof beam

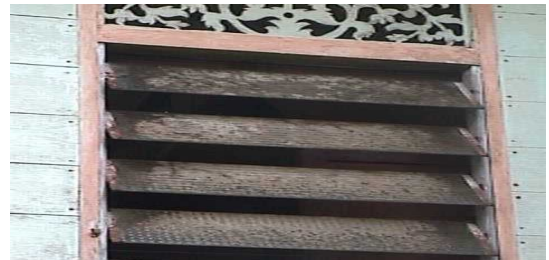
a. Refer to Figure 28, the surface of the window was dirty and dusty as it has not been cleaned by the users for ages.

Figure 28: Dirty window surface

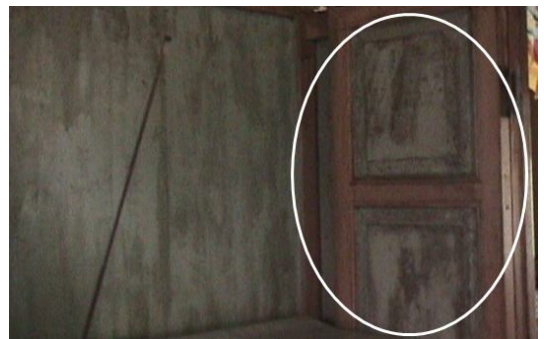
a. Refer to Figure 29, dirt on the surface of the door was due to the thick dust that has not been cleaned off

Figure 29: Dirty door surface

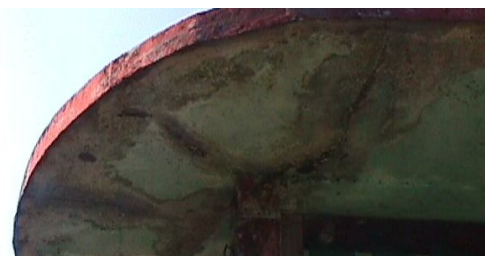
a. Refer to Figure 30(a), absorption of water into the concrete roof was due to the leaking water tank.

Figure 30(a): Water stains on concrete roof

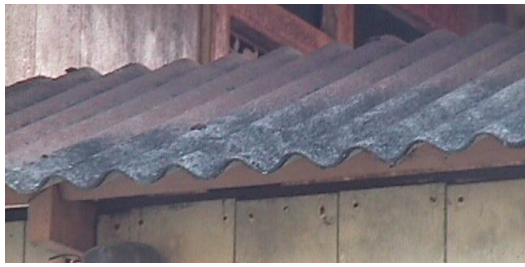
b. As in Figure 30(b), dirt was accumulated on the surface of the roof finishes as it was often exposed to the tropical weather.

Figure 30(b): Dirty roof finishes

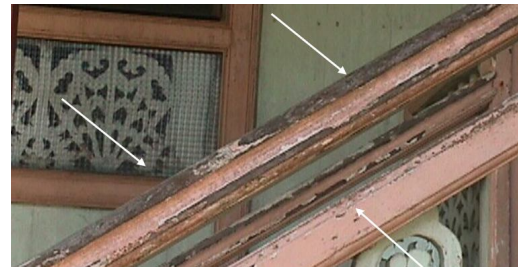
Figure 33: Peeling paint finishes

a. Refer to Figure 33, paint finishes on the handrail of the staircase have peeled off because of the frequent exposure to the hot and humid tropical weather.

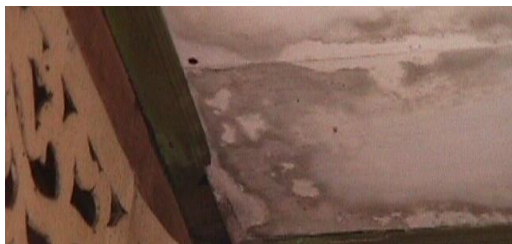
a. Refer to Figure 31(a), stains were found on the ceiling as a result of roof leaks.

Figure 31(a): Water stains on ceiling

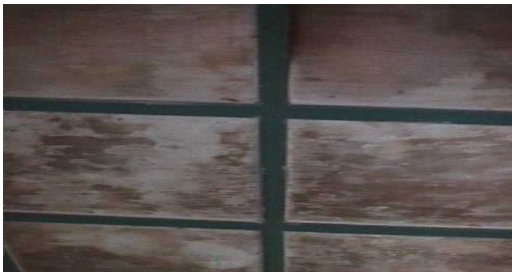
b. As in Figure 31(b), stains and mosses were seen on the ceilings which were caused by a leaking roof.

Figure 31(b): Mosses on ceiling

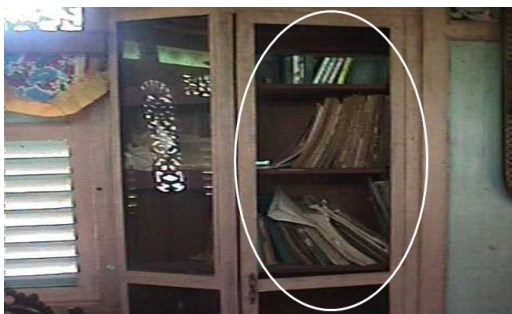
a. Refer to Figure 32, individual pieces of glass on the prefabricated bookshelf has broken as a result of heavy usage.

Figure 32: Broken glass cabinet door
