Slope Inspections with Unmanned Aerial Vehicle (UAV)

The scope of this study involves the monitoring of the surface structure of the slope near the exit Plaza Tol Ayer Itam, North-South Expressway. It is as a new alternative to facilitate the work of inspection structure slopes in the study area are maintained by the OPUS Network Maintenance Management. The study area was chosen because one of the slopes that are categorized as type A (high) situated at the exit toll plaza, North-South Expressway [9].

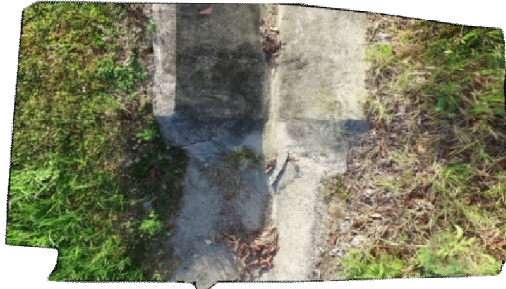
Figure 9: Damage Analysis of 3D models Crack No 1

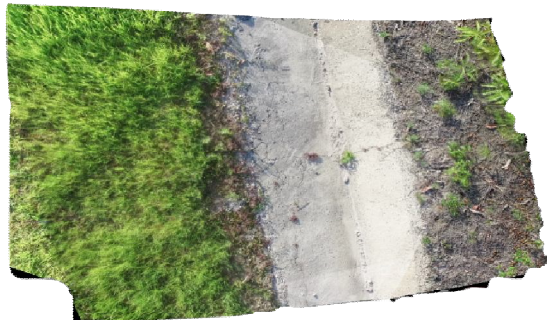
Figure 10: Damage Analysis of 3D models Crack No 2

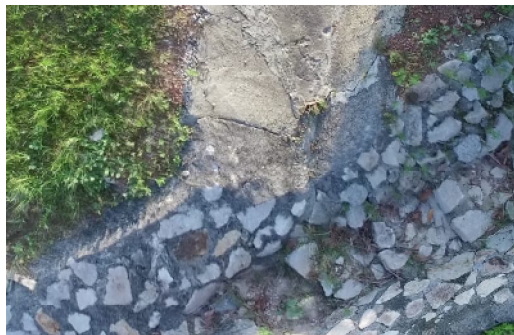
Figure 11: Damage Analysis of 3D models Crack No 3

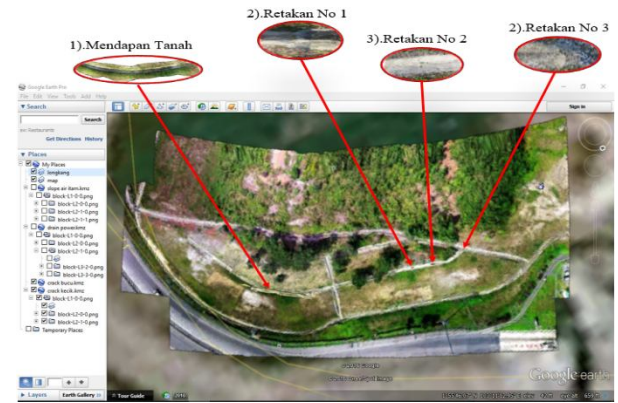
The entire 3D damaged model is linked to the overall structure of a 3D model of the slope using Google Earth Pro software, as shown in Figure 12. Finally, the coordinates of the damage can be identified from Google earth pro, as shown in Table 1.

Figure 12: Damage position at The Slope Structure in Google Earth Pro

Damaged No.	Latitude	Longitude
1	1°55'46.00"N	103°11'14.17"E
2	1°55'46.56"N	103°11'12.36"E
3	1°55'46.66"N	103°11'12.04"E
4	1°55'46.67"N	103°11'11.64"E

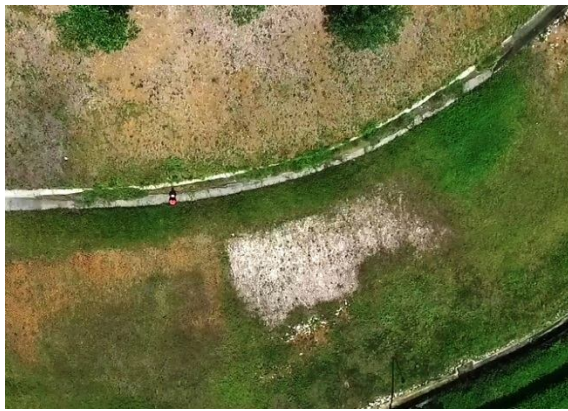
This data analysis is to examine the extent to which the maximum height of the UAV in the air to take pictures in the work of monitoring the slope structure. Based on the analysis of data that previously, there are only two types of damage that occur on the slopes of the study area vegetation coverage and cracked. Micro UAV has been flown over the damaged area. At the height of each meter, the existing cameras on UAV will capture the image starting from a distance of 1 meter until 50 meters on the damaged area. The results of observation, there is a difference where image clarity with altitudes shooting depends on the type of damage. Damage caused by vegetation coverage can still be identified even at height of 50 meters as shown in Figure 13, but for the damage of cracks at height of 10 meters is starting to blur and at an altitude of 12 meters of cracks image is not clear. Therefore, the maximum image height of the damage type of crack is only 9 meters as shown in Figure 14 and for the damage of plant coverage is as high as 50 meters from the slope surface structure.

Figure 13: Zoom Image for Vegetation Coverage at Height 50 Meters

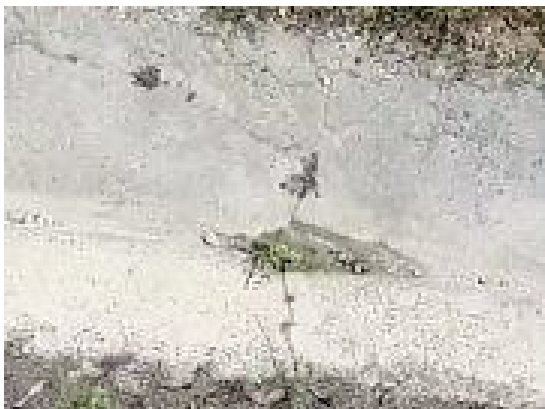
Figure 14: Zoom Image for Crack at Height 9 Meters
