Selected Melaka traditional houses: comprehensive analysis on building defects, failures and solutions including the Chetti house

Key words: building defects, construction failures, building leakage, Malaysia.

1. MALACCA CHETTI ASSOCIATION HOUSE

2. MRS KASMAH BINTI YASSIN'S HOUSE

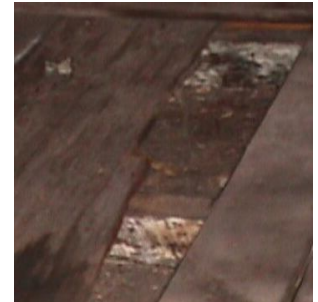
b. As in Figure 1(b), it can be seen that the floor boards that have been detached from the fixed position was due to decay caused by roof leaks on the first floor.

Figure 1(b): Detached boards

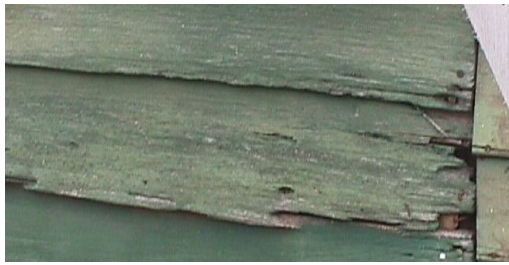
a. Refer to Figure 2(a), the wallboard has rotted as a result of exposure to the hot and humid weather.

Figure 2(a): Rotted wallboard

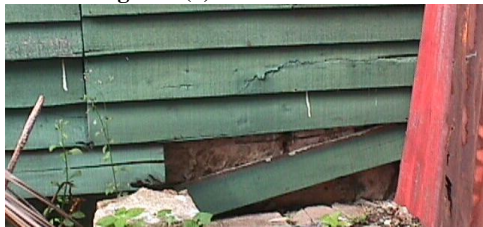
b. As in Figure 2(b), it can be seen that the wallboard has fallen off because of the low quality installation.

Figure 2(b): Falling off wallboard

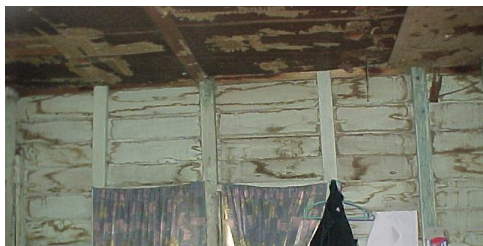
c. Refer to Figure 2(c), the dirty stains were due to the absorption of rainwater from the outside of the house.

Figure 2(c): Dirty stains on walls

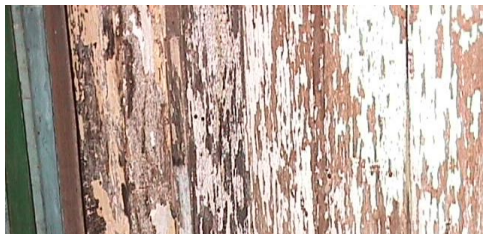
d. As in Figure 2(d), the peeling paint finishes was caused by the seepage of rain water from the outside of the building.

Figure 2(d): Peeling paint finishes

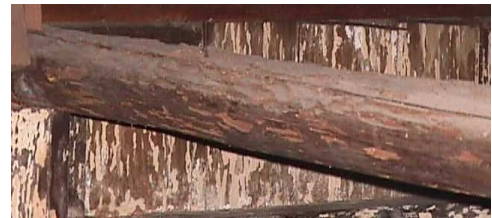
- Refer to Figure 4(a), the decayed roof crossbeam was due to termite infestation.
- As in Figure 4(b), the floor crossbeam has rotted because of the water infiltration from the leaking roof.

Figure 4(a): Decayed roof crossbeam

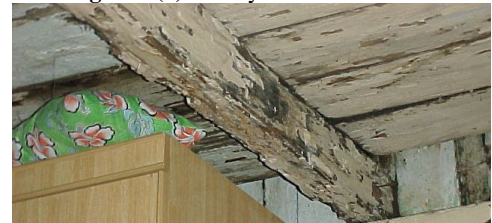
Figure 4(b): Rotted floor crossbeam

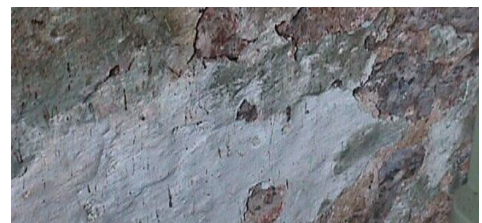
- Refer to Figure 6(a), the plaster has come off because of the low quality finishing work on the ground floor brick stairs.
- As in Figure 6(b), the wood staircase and handrails are unstable as they often absorb the water from the leaking roof.

Figure 6(a): Falling off plaster

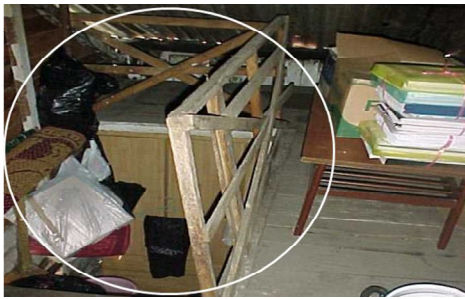
Figure 6(b): Unstable wood staircase and handrails

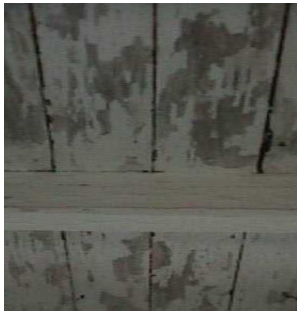
a. Refer to Figure 7(a), the paint finishes on the wooden ceiling surface were peeling off as a result of lack of maintenance by the building occupants.

Figure 7(a): Peeling paint

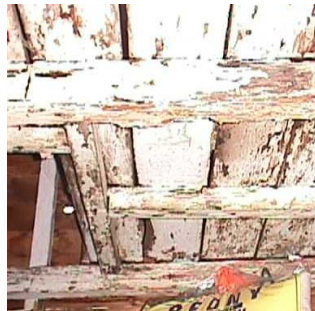
b. As in Figure 7(b), the finishes on the wooden ceiling surface and the girders were peeling off and decaying.

Figure 7(b): Decaying ceiling

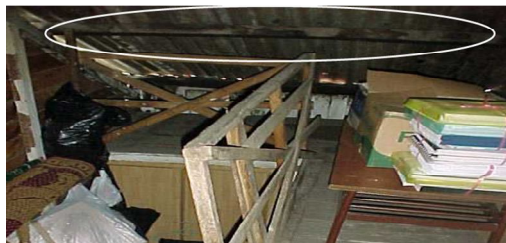
a. Refer to Figure 8, the dirty stains were caused by water infiltration into the rafters from the leaking roof.

Figure 8: Dirty stains on roof rafter

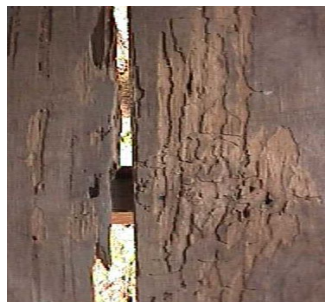
- a. Refer to Figure 10(a) and 10(b), the floor boards that have rotted were caused by termite infestation.
- b. As in Figure 10(c), it can be seen that there are insect nests on the surface of the floor outside the house.
- c. Refer to Figure 10(d), the joists and floor boards have decayed due to termite infestation.

Figure 10(a): Rotted boards

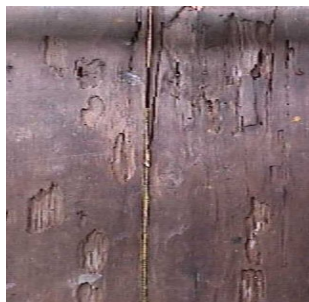
Figure 10(b): Rotted floor

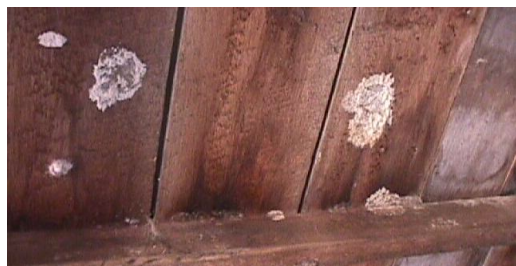
Figure 10(c): Insect nests on floor surface

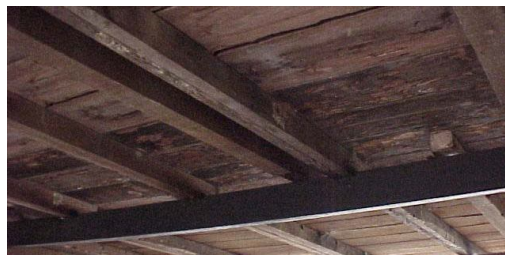
Figure 10(d): Decayed joists and floor boards

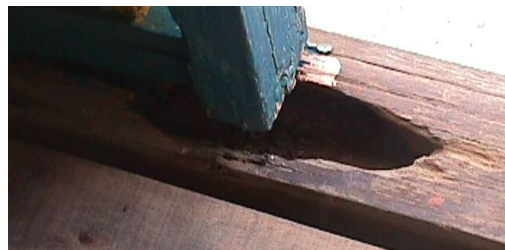
- a. Refer to Figure 11, the rotted sill, which is a wooden beam encircling the outer floor regions, was due to termite attack.

Figure 11: Rotted sill

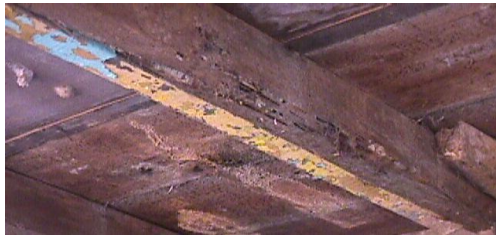
- a. Refer to Figure 14(a), the faded wooden colour of the floor crossbeams was due to the lack of maintenance by the owner.
- b. As in Figure 14(b), the wood colour of the roof crossbeams has faded as a result of rainwater absorption.

Figure 14(a): Faded wooden colour

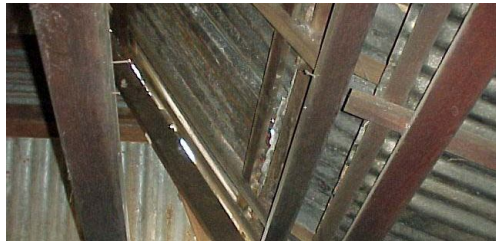
Figure 14(b): Faded wooden colour

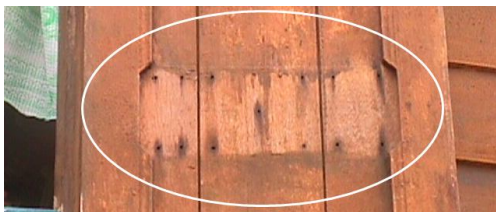
- a. Refer to Figure 15(a), the window panel has fallen out as a result of the poor installation.
- b. As in Figure 15(b), the rotting window frame was due to infiltration of rainwater.

Figure 15(a): Poor installation window panel

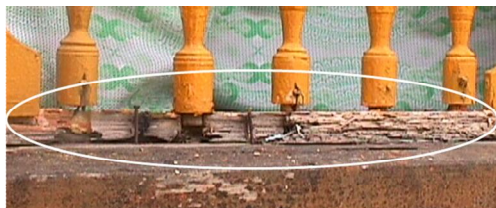
Figure 15(b): Rotted window frame

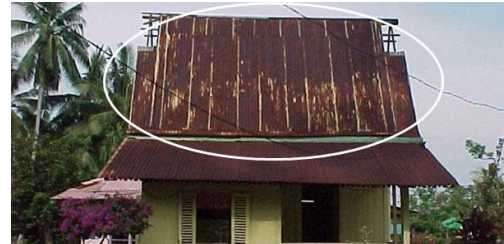
- a. Refer to Figure 16(a), the zinc finishes of the roof have rusted and rotted because of the weathering effect.
- b. As in Figure 16(b), the zinc finishes have fallen off as a result of the strong blowing wind.
- c. Refer to Figure 16(c), the “tebar layar”, which means “sailed ready” for roofing ventilation, has rusted and decayed from the exposure to tropical rain.
- d. As in Figure 16(d), the joining of the “papan pantor”,

Figure 16(a): Rusted zinc roof finishes

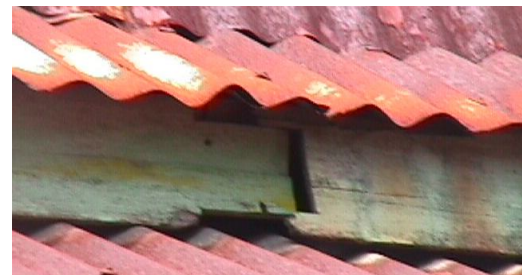
- which is a type of fascia board that decorates the roof and also acts as a cover at the end of the roof rafters, has loosen.
- e. Refer to Figure 16(e), the zinc finishes of the roof have holes on it because of the decaying of the zinc.
- f. As in Figure 16(f), the rotted beam was due to the absorption of water from the leaking roof.

Figure 16(d): Loosen “papan pantor”

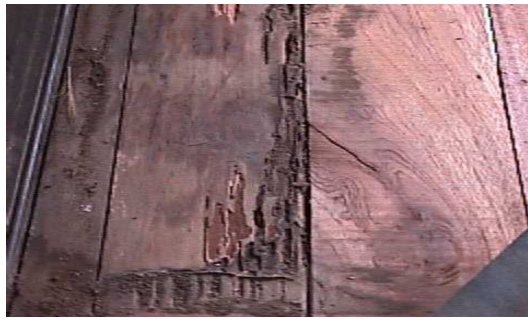
a. Refer to Figure 18(a) and 18(b), the floor boards were rotted because of the infestation by termites.

Figure 18(a): Rotted floor boards

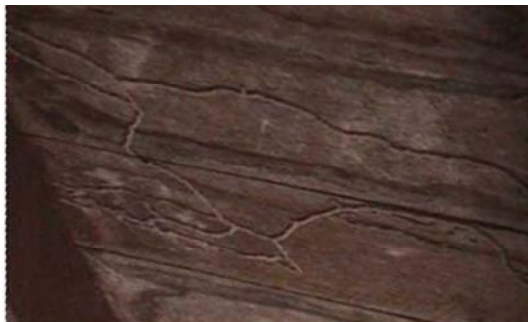
Figure 18(b): Rotted floor boards

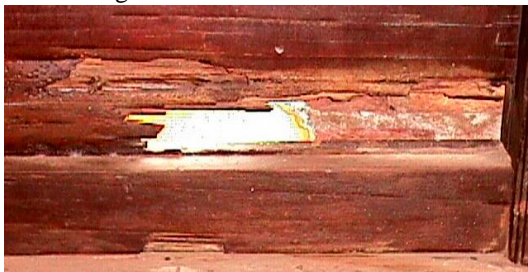
a. Refer to Figure 19(a) and 19(b), the decayed wall was due to termite infestation.

Figure 19(a): Decayed wall

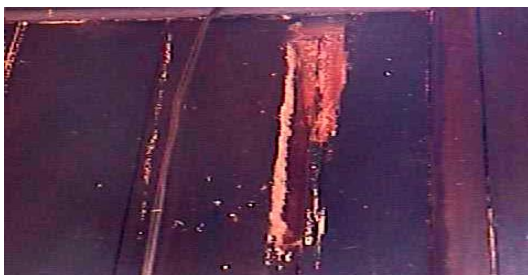
Figure 19(b): Rotted wall

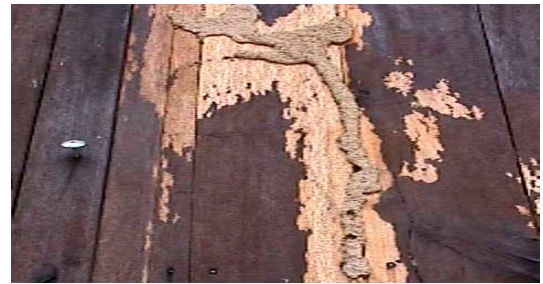
b. As in Figure 19(c), it can be seen that pest nests are found on the timber wall.

Figure 19(c): Pest nests on timber wall

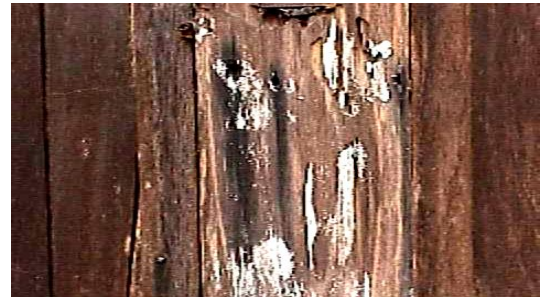
c. Refer to Figure 19(d), the wall has deteriorated as a result of the weathering factor.

Figure 19(d): Deteriorated wall

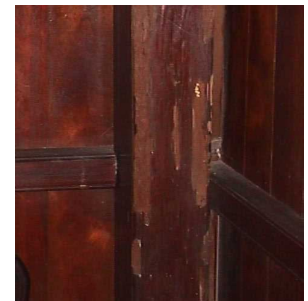
a. Refer to Figure 20(a) and 20 (b), the pillars were decaying because of termite infestation.

Figure 20(b): Rotted pillar

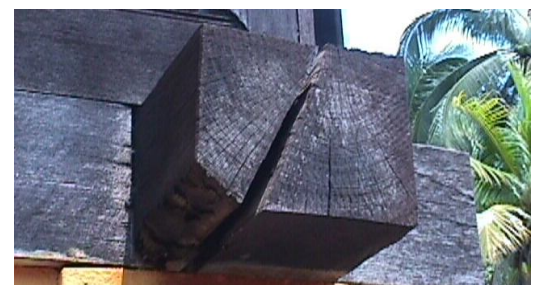
a. Refer to Figure 21(a), the floor crossbeam was cracked and split as a result of a failure in the connection.

Figure 21(a): Cracked floor crossbeam

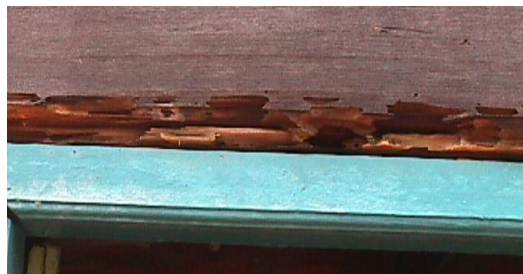
b. As in Figure 21(b), the floor crossbeam which experiencing serious decay was due to termite attack.

Figure 21(b): Decayed floor crossbeam

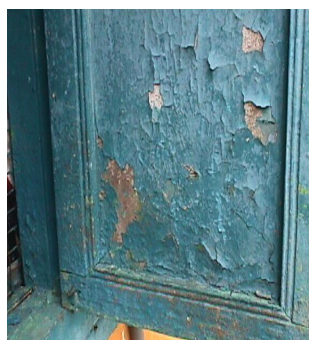
a. Refer to Figure 23(a), the peeling paint on the surface of the window leaf was due to the weathering factor.

Figure 23(a): Peeling paint

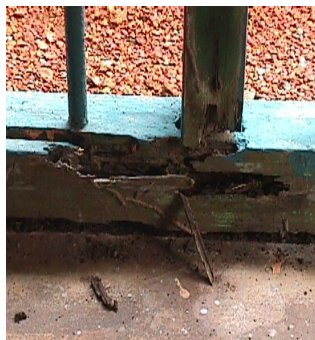
b. As in Figure 23(b), the window frame has rotted as a result of the termite attack.

Figure 23(b): Rotted frame

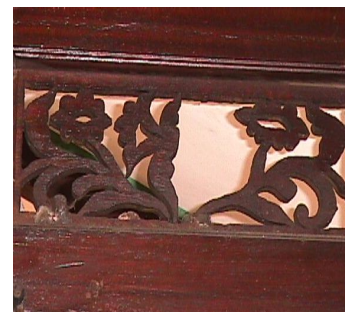
a. Refer to Figure 24(a) and 24(b), the motifs on the fretworks were broken.

Figure 24(b): Broken fretwork

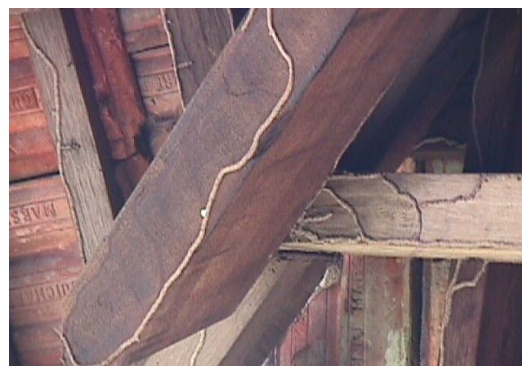
a. Refer to Figure 25(a), termites has infested the roof rafters.

Figure 25(a): Termite-infested roof rafter

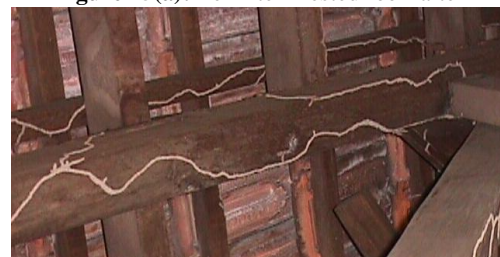
b. As in Figure 25(b), the rafter and roof beam have been attacked by termites.

Figure 25(b): Termite-attacked rafter and roof beam

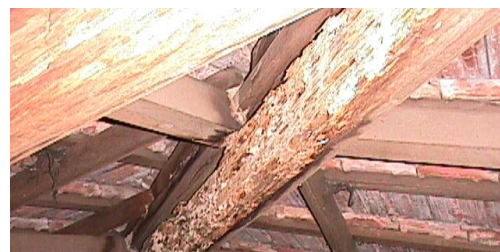
c. Refer to Figure 25(c), the roof rafter has decayed as a result of termite infestation.

Figure 25(c): Decayed roof rafter

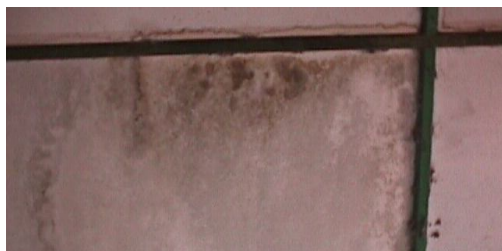
d. As in Figure 25(d), dirty stains were seen on the ceiling surface because of the water absorption from the leaking roof.

Figure 25(d): Dirty ceiling surface

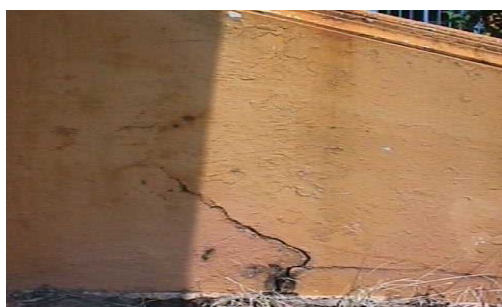
a. Refer to Figure 26(a), cracks were due to the vibration from the nearby road.

Figure 26(a): Cracked stairs

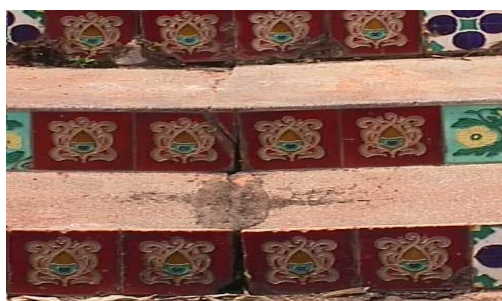
b. As in Figure 26(b), cracks were seen on the steps as a result of the vibration from the nearby road.

Figure 26(b): Cracked steps

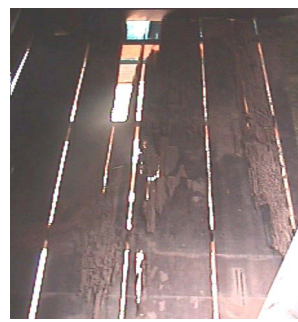
Figure 28(c): Rotted floor

b. As in Figure 28(c) and 28(d), the floors have rotted as a result of termite attack.

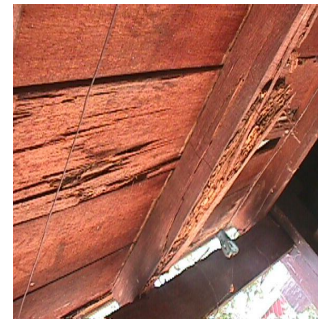
Figure 28(d): Rotted floor

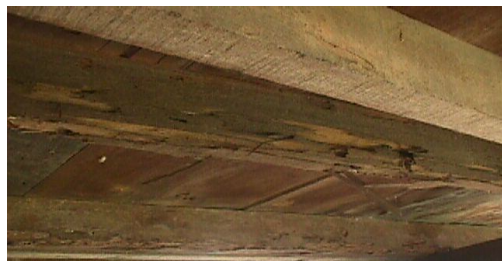
a. Refer to Figure 28(a) and 28(b), the rotted floor girders were due to termite infestation.

Figure 28(a): Rotted floor girders

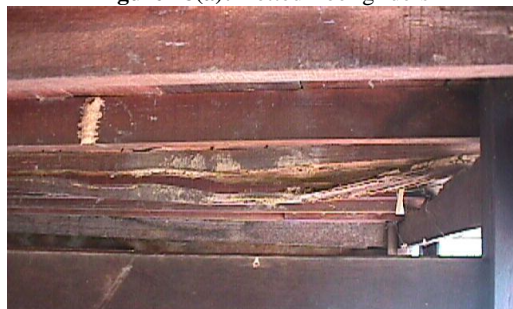
Figure 28(b): Rotted floor girders

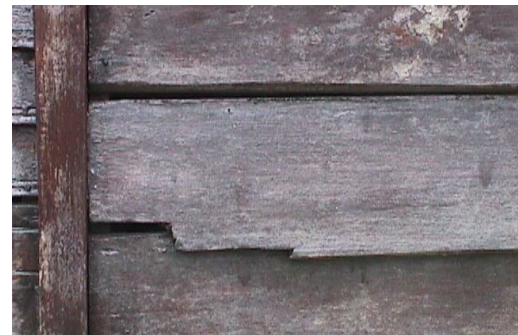
Figure 29(a): Faded wood colour

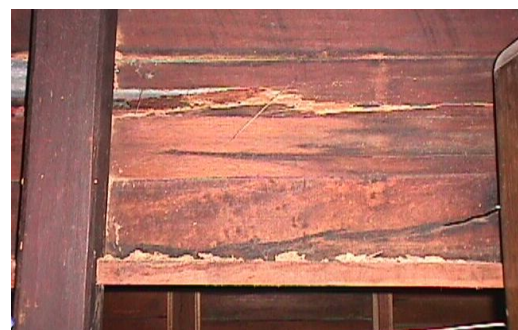
Figure 29(b): Rotted wallboard

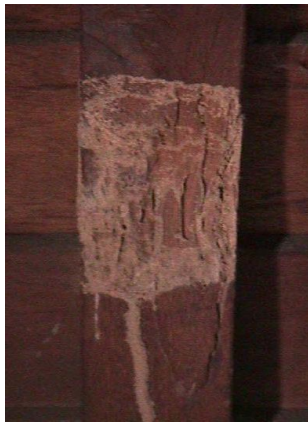
c. Refer to Figure 29(c), the wall ledge has rotted as result of termite infestation.

Figure 29(c): Rotted ledge

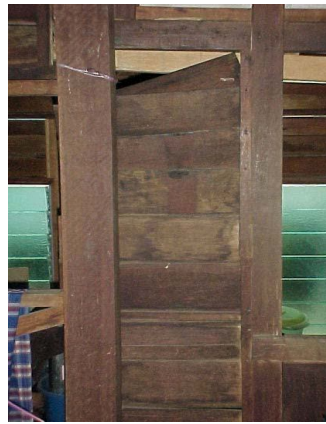
d. As in Figure 29(d), the wall board has fallen off and the installation was untidy.

Figure 29(d): Fallen wall

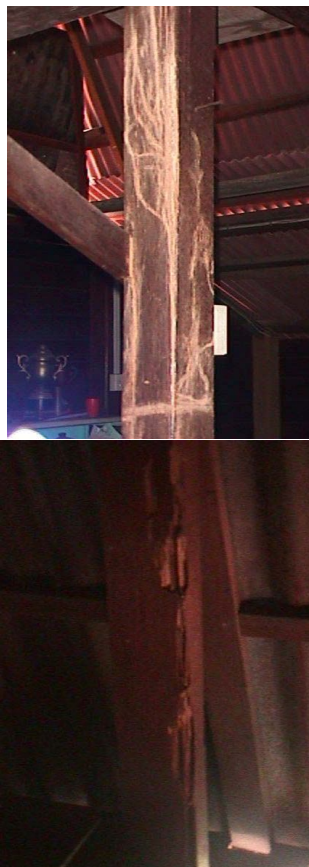
a. Refer to Figure 30(a), the pillar was decaying because of the infestation of termites.

Figure 30(a): Decayed pillar

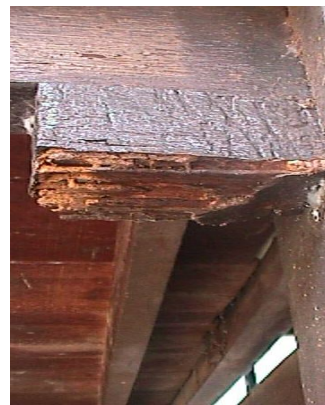
a. Refer to Figure 31(a), the floor crossbeam was decaying because of termite infestation.

Figure 31(a): Decayed crossbeam

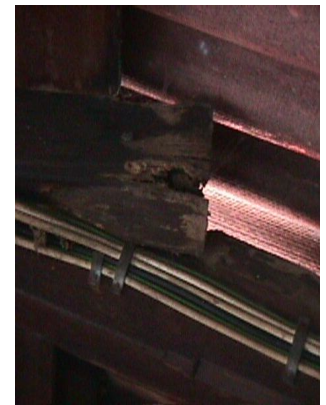
b. As in Figure 31(b), the end part of the roof crossbeam has rotted as a result of the absorption of rainwater.

Figure 31(b): Rotted crossbeam

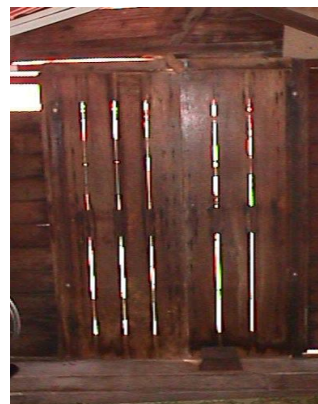
a. Refer to Figure 32(a), the loosen door was due to the wear and tear factor, while the faded wood color was due to environmental factor.

Figure 32(a): Loosen door

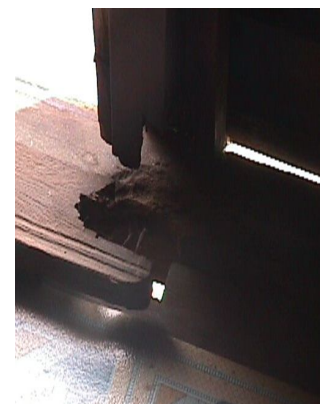
b. As in Figure 32(b), the door frame has deteriorated as a result of the rainwater absorption and the wear and tear factor.

Figure 32(b): Rotted door frame

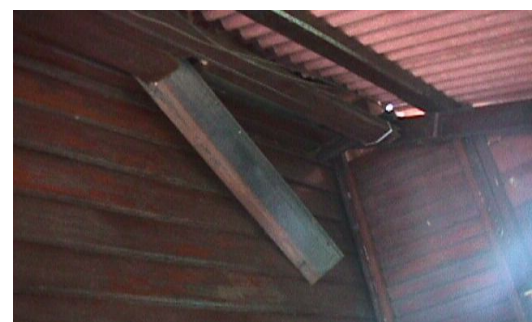
a. Refer to Figure 33, the broken ceiling was due to the wear and tear factor.

Figure 33: Broken ceiling

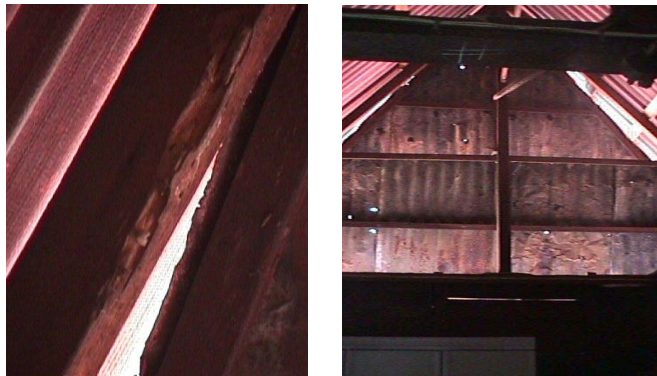
a. Refer to Figure 34(a), the main rafter in the house attic has decayed as a result of termite infestation.

b. As in Figure 34(b), the “tebar layar” which is made of zinc has rusted from the exposure to rain.

Figure 34(a): Rotted rafter Figure 34(b): Rusted “tebar layar”
