# Failure Analysis to 2000 Liter Capacity Light Filter Tank Wall Filter

Ahmad Zayadi, Cahyono Heri P, Sungkono, Kis Yoga Utomo

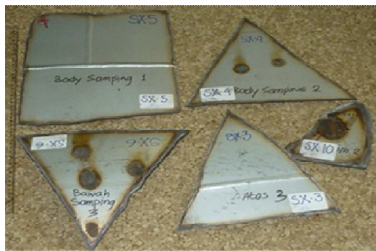
**Figure 3 :** Pieces of filter tank walls from different places.

Results of the macrostructure examination of 5 (five) pieces of soft drink filter tank walls in different places (figure 3). The selection of the five pieces is based on visual inspection that the sample is focused on the welded joint and the damaged area with code: SX-3, SX-4, SX -5, SX-6 and SX-10. On the SX-3 code tank wall pieces, the inside surface of the tank wall does not show any corrosion or other defects while in the SX-4 code tank wall pieces a corrosion attack occurs and there are two welding locations on the inner surface. This corrosion is indicated to spread to form crevice corrosion.

SX-5 code tank wall pieces, no significant corrosion attack was seen, only corrosion stains, while in SX-6 code tank wall pieces, there were 4 (four) welding sites on the inner surface and clearly visible local corrosion attacks. This corrosion is indicated by pitting corrosion in the form of small holes on the inner surface of the tank wall.

SX-10 code tank wall pieces, there are indications of elongated cracks and bulging in the area of Heat Affected Zone (HAZ) and Weld Metal (WM) as shown in the results of macro inspection which shows corrosion attacks occur in the area of Heat Affected Zone (HAZ) and weld metal (WM). Also found fibers in the hole, blackish brown and neatly arranged in the area of the Heat Affected Zone (HAZ) and suspected to be metal phases corroded due to chemicals in the tank.

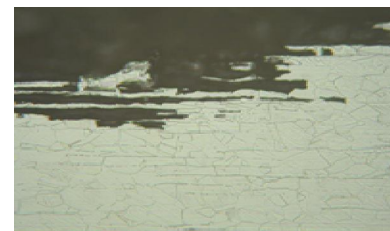
**Figure. 5 :** SX-6 macro and microstructure at 500x micro photo welding location corrosion area

In the SX-6 sample, it was clear that the welding process defects in location (1 and 2) were due to imperfections in the process, namely the presence of a corroded tank wall had not been filled with welding material and was still unclean in the grinding process. Microstructure of SX-6 in the form of austenite with a form of corrosion attack that develops on the surface and this corrosion event is considered serious and

dangerous. Welding defects in SX-6 sample are porosity with a microstructure of welding material in the form of austenite.

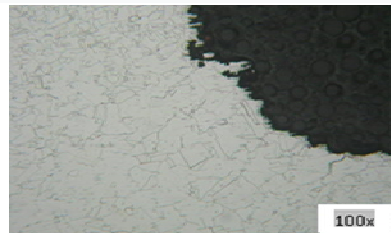
**Figure 6 :** Microstructure of basic material in the form of austenite and experiencing grain boundary cracking (intergranular cracking)

At the location of the SX-10 welding piece, fibers were found in the corroded hole, the fibers were blackish-brown and neatly arranged in the hole in the Heat Affected Zone (HAZ) area and indicated as metal phases corroded due to chemical fluids in the tank the. In the micro etching photo, a corrosion attack occurred in the Heat Affected Zone (HAZ) and Weld Metal (WM) areas. Seen in Figure 6, the microstructure of the welding material is in the form of austenite and has grain boundary cracking (intergranular cracking)

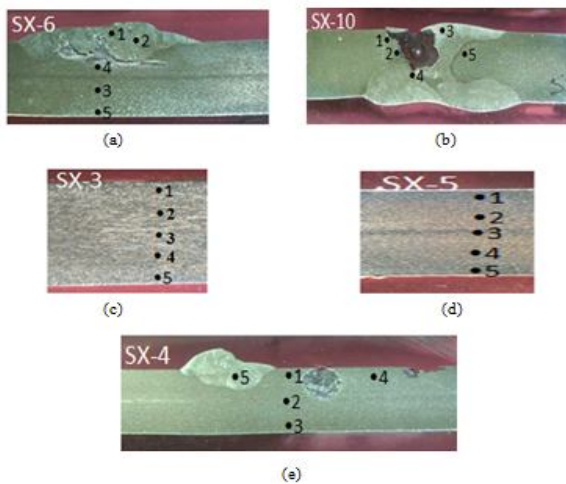
Figure 7. Hardness of test sample

Hardness test results of the soft drink tank filter wall of the five samples have significant differences, especially in the area of the Heat Affected Zone (HAZ) as in the SX-4 test mark 5 (five), the value of hardness is below standard (228 HV) that is 214 HV, in SX -6 test marks 1 and 2, hardness value 181-182 HV and on SX-10 test mark 3 (three), hardness value of 185 HV from the results of all hardness values in the Heat Affected Zone (HAZ) area, it can be seen that the decrease in violence is allegedly due to there is a change in the size of the grains which is getting bigger and

equiaxial in the form of a recrystallization mechanism with higher temperatures and longer welding times. At the location of SX-3 pieces the value of hardness exceeds the standard value of hardness because the area of the parent metal is not touched by the welding process, but at SX-5 pieces the value of hardness at test marks 1, 2 and 3 has decreased violence allegedly due to the cooling process of welding temperature that is too fast. In Table 1 it is known that the average hardness value ranges from 181.4-268.6 HV.
