Factor effecting typical interior defects (water based) found in Malaysian buildings. With real selected case samples

Roslan Talib¹, A Ghafar Ahmad², Mohd Zailan Sulieman³

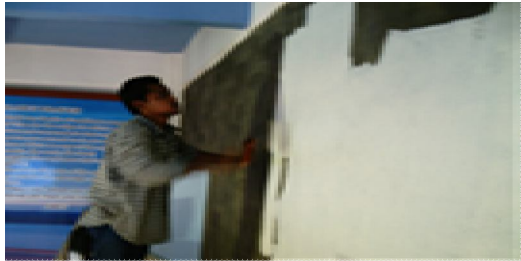
Figure 1: Interior dampness rectification work been treated for this museum interior been treated by maintenance crew

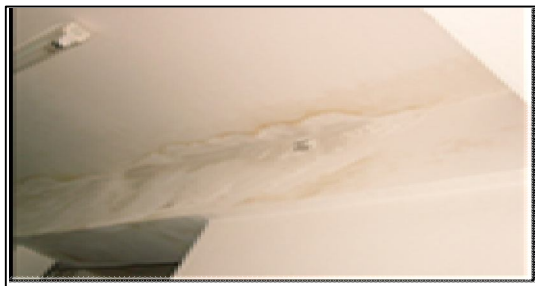
Figure 2: The dampness effects clearly be seen at this beam due to minor leakage from the above wet area

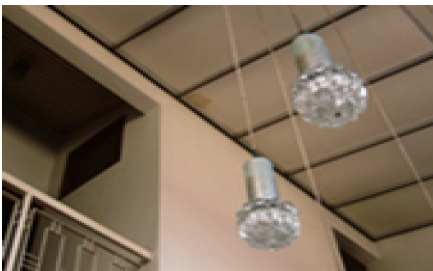
Figure 3: Defect found with stained ceiling tile at this double height space with elaborate lighting invites problem

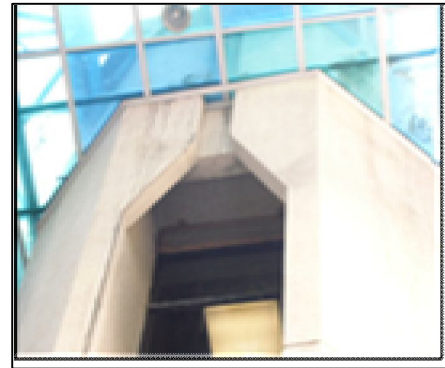
Figure 4: Dampness being created from the expired sealant of the skylight and can be tracked from the stained wall of this interior of an office building

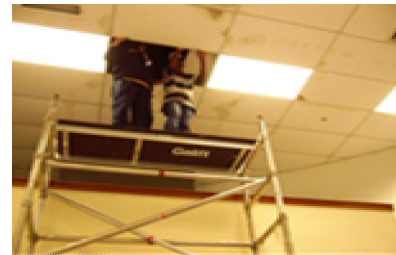
Figure 5: Workers checking the dampness space between the ceiling interior and the underneath concrete slab

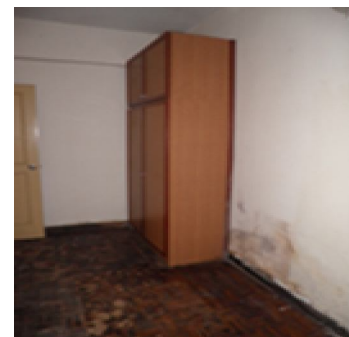
Figure 6: The dampness creating worse scenario of this bedroom with stained wall affecting the wardrobe and floor parquet timber material

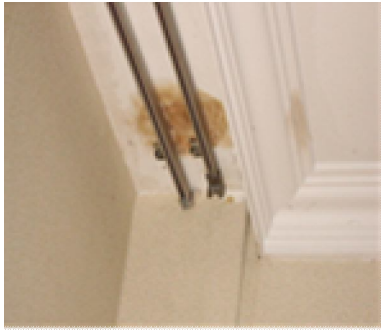
Figure 7: The chalking content of the plaster ceiling speeding-up the dampness effect at this curtain railing spots of this luxury hotel room. It is known that water seepage through plaster ceiling easily can create unwanted holes and the damage outlook

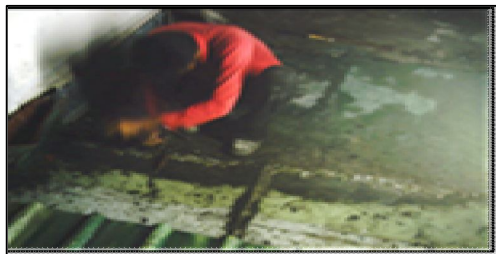
Figure 8: A rare view of the internal part of an enclosed space having the water ponding effect letting seepage to the public interior space below

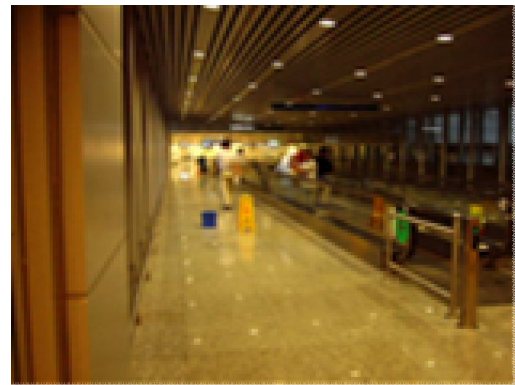
Figure 9: The photograph shows plastic pail has to be located at the spots where the water leakage, this one next to walkalator linking parking to terminal building

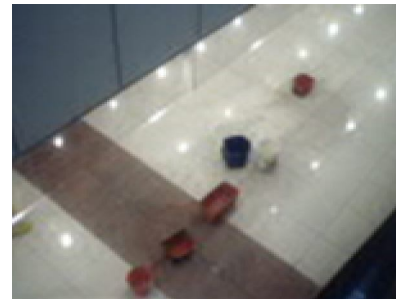
Figure 10: The photograph shows numbers of plastic pails have to be located at the spots where the water leakage happened due to the cracks allowing water seepage at this important public area

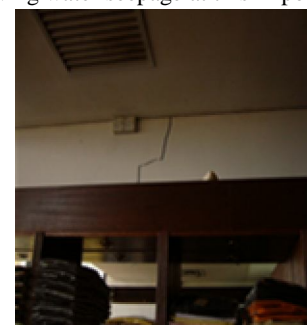
Figure 11: Crack appears at the beam possible due to building movement and requires immediate attention.

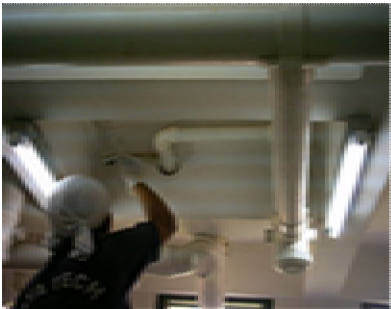
Figure 13: Another spot with typical problem due to the under slab concrete leakage with clear stained marked on it possible due to building movement.

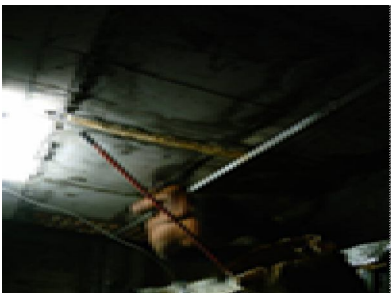
Figure 14: Under slab concrete leakage with clear stained marked on it possible due to building movement. It also shows stalactites beginning to form and create problem to the interior users

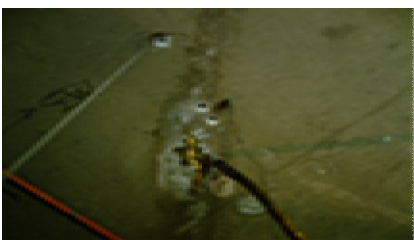
Figure 15: The photograph shows the worker using the packer to inject the p.u. grout into the crack

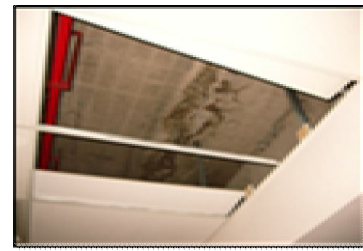
Figure16: This one shows the worker using the packer to inject the p.u. grout into the crack. This tedious rectification works must be handled with professional building pathology agent

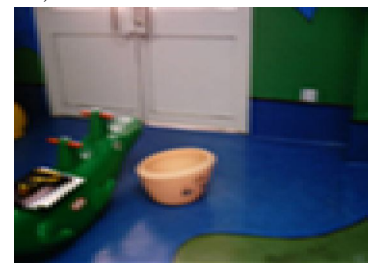
Figure 18: Notice the linoleum flooring found at this hospital's children playground detaching itself due to water seepage

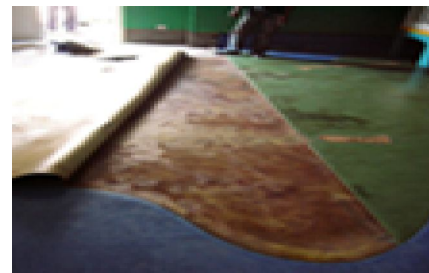
Figure 19: Closure look on the linoleum flooring found at this hospital's children playground detaching itself due to water seepage

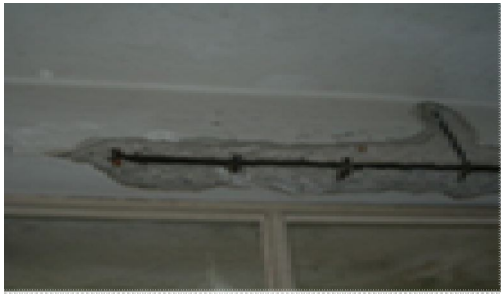
Figure 20: Structural repair required for this concrete spalling task due to detachment defects found at this internal part of the room

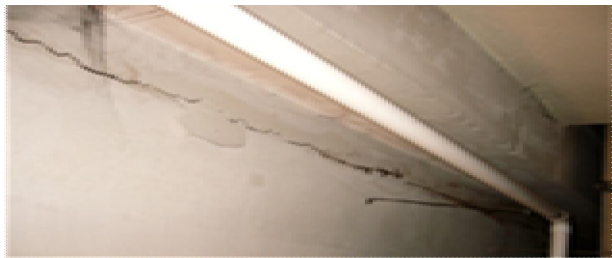
Figure 21: This concrete beam running through-out the toilet showing its detachment process in the making due to water leakage from the top wet area.

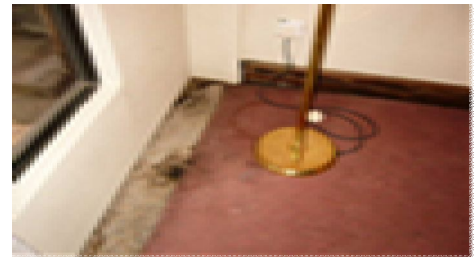
Figure 22: Having carpet material easily over run the glue and making the detachment process easily been done from the concrete floor slab of this office space

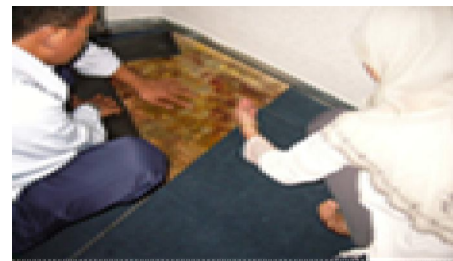
Figure 24: The detachment is found inside the prayer space of an office

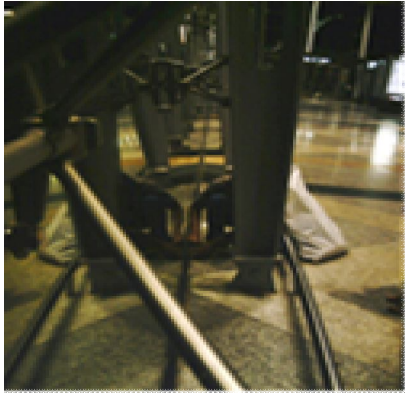
Figure 25: Maintenance crew replacing expired sealant using high quality GE brand building sealant between the marble floor and glass wall. It is found out that the same brand of sealant used for NASA space shuttle as specify on the product brochure

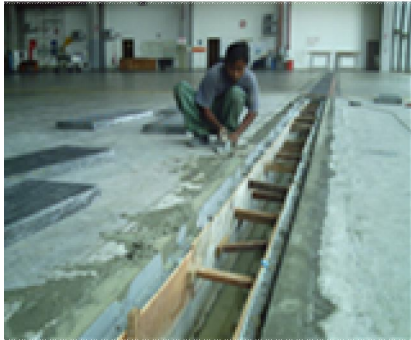
Figure 26: The wear and tear of the floor material pays its toll due to the heavy vehicle load as well due to frequent traffic usage at airport hangar building

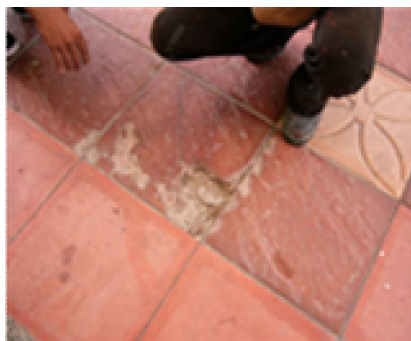
Figure 27: The wear and tear of the floor material pays its toll due to the heavy vehicle load as well due to frequent traffic usage found at drop-off part of the building

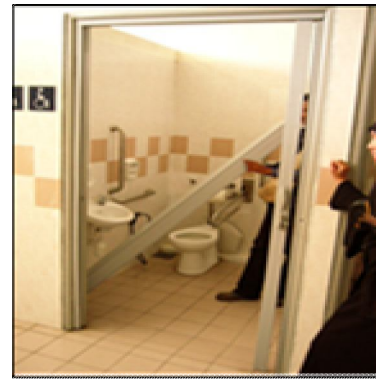
Figure 28: Wear and tear usage for disable toilet folding door inside the male handicapped toilet

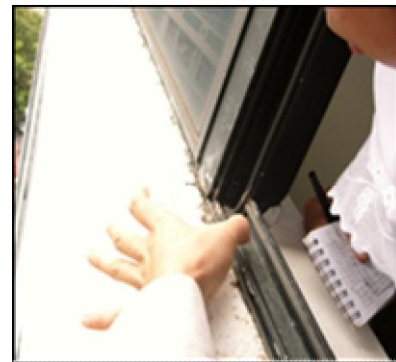
Figure 29: Wear and tear usage for the expired window sealant found at an office building

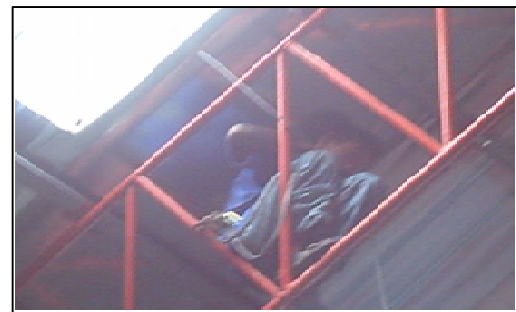
Figure 30: The maintenance crew squeezing himself in making rectification work repairing the hole using the fiber mat and antirust paint for this internal part of the metal roof material.

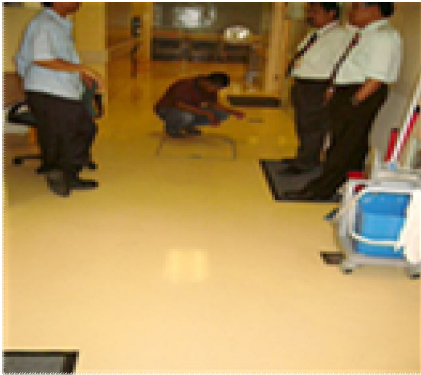
Figure 31: The wearing and tearing of this linoleum let the peeling-off and unwanted bubbles appear and started to look ugly

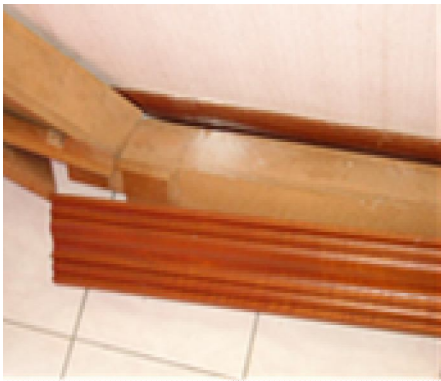
Figure 32: Wear and tear of the timber skirting and parquet floor with the help of the humidity of the internal space creating this mess

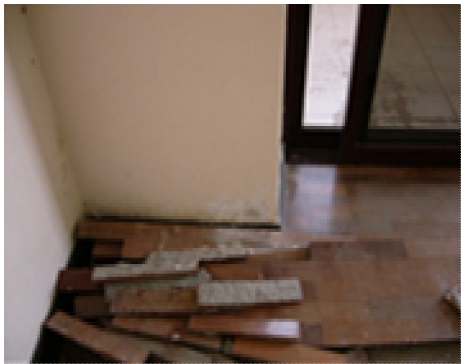
Figure 33: Wear and tear of the timber skirting and parquet floor with the help of the humidity of the internal space creating this mess

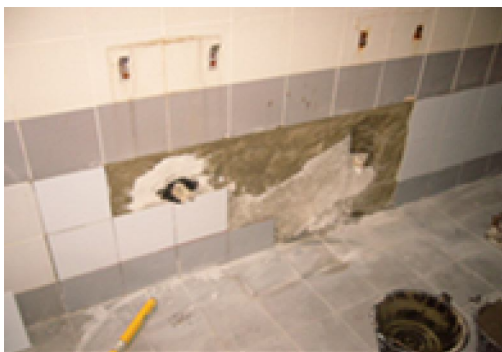
Figure 34: Rectification work is being done to replace the peel-off ceramic wall tile due to harsh usage and sink leakage of this toilet area. Water proofing material need to be done on the effected wall as well as sink plumbing's pipe connection must be done correctly.

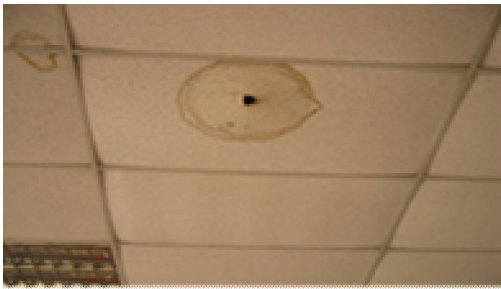
Figure 35: Possible fungus formation seen at this ceiling tile may hazard the occupant of this space and also can become an ideal breeding space for termites to make a colony.

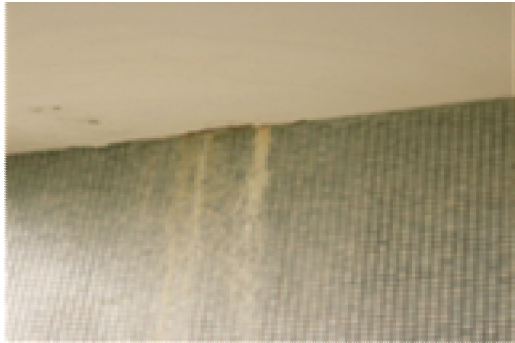
Figure 36: The possible fungus colony here at the mosaic wall is created from the water seepage from the edge of the floor and concrete wall as found at this academic building.

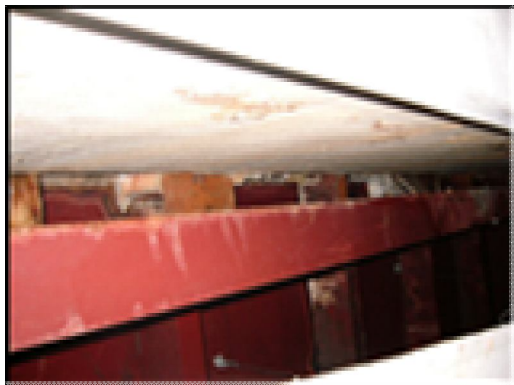
Figure 37: The formation of hazard like condition may let fungus to grow even on top of the paint layers of these concrete floor slabs. The interior become unhealthy due to tiny particle trapped inside the room

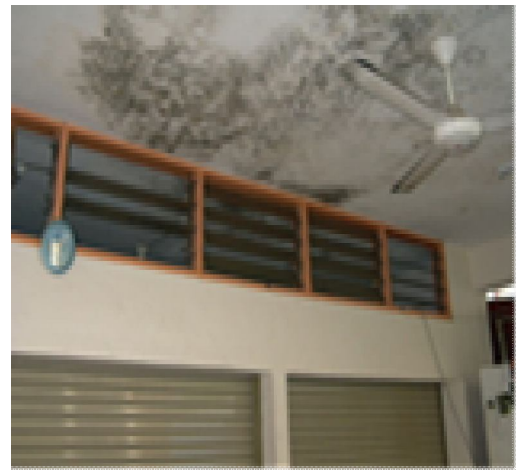
Figure 38: The formation of hazard like condition may let fungus to grow even on top of the paint layers of these concrete floor slabs. The interior become unhealthy due to tiny particle trapped inside the room

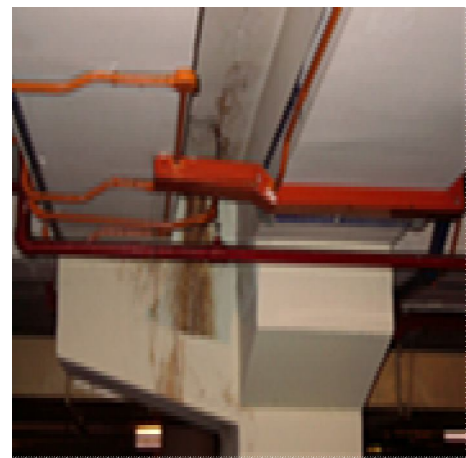
Figure 39: These are another example of the hazardous fungus effects particles found within the interior space of this leakage concrete. This defect found within the internal part of the parking basement area and getting worse affecting the parked cars

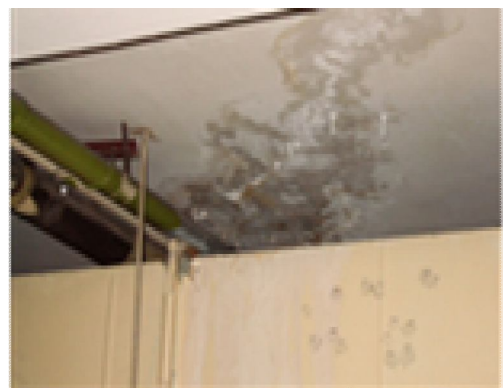
Figure 40: These are another example of the hazardous fungus effects particles found within the interior space of this leakage concrete. This defect found within the internal part of the parking basement area and getting worse affecting the parked cars.

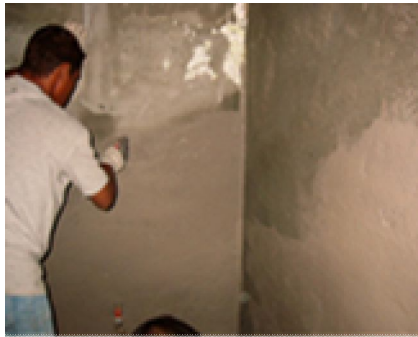
Figure 41: Anti-fungus coating is being applied for this rectification work of an interior space. The task requires expert personnel to ensure the space back to its original condition and in reusable state

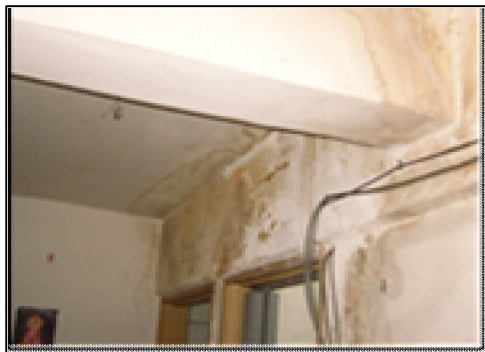
Figure 42: Anti-fungus coating is being applied for this rectification work of an interior space. The task requires expert personnel to ensure the space back to its original condition and in reusable state

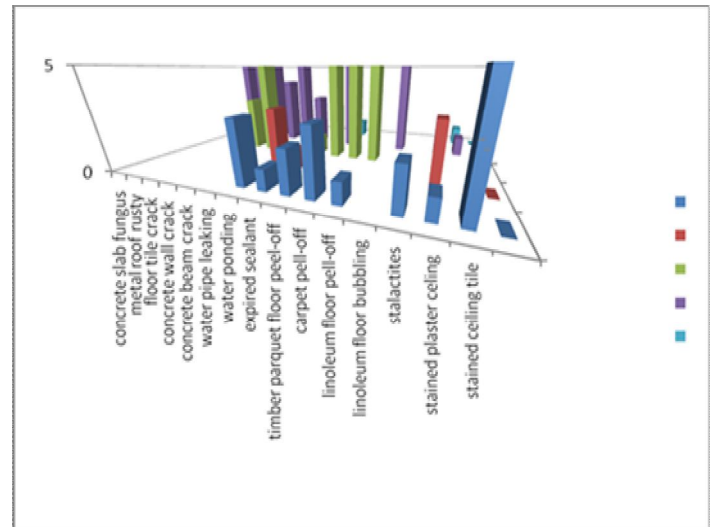
Figure 43: Summary graphs showing the factors of internal defects awarded point quick survey analysis
