Visual Inspection of High Risk Slope by Micro-UAV Air-craft

The study involved examining the surface structure of the slope at Bukit Setiawangsa, Kuala Lumpur and a slope that was once the occurrence of landslides and categorized as class IV (high) with a residential area on the slopes. The slopes also have steep angles and the area is relatively large [10].

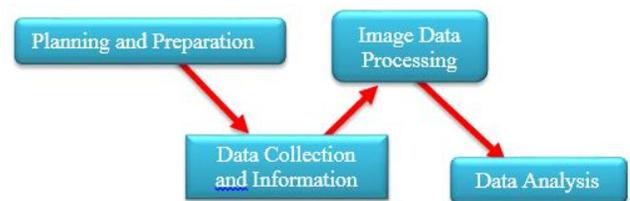
The research methodology of this study is to ensure that the data collection methods used to be achieved the objectives. Figure 2 below describes briefly the overview of the process and workflow involved in the study.

Figure 2: Workflow process

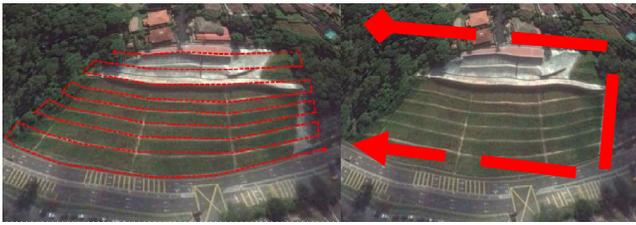
There are two methods of data collection in this study. The first method is a snapshot image of the distance of 2-5 meters as shown in Figure 3(a) from the slope surface using horizontal flight patterns to identify the image damage to the structure of the slope and snapshot image for a distance of 30 meters from the downslope to produce slope structure in the 3D model using software Agisoft PhotoScan and detect failure by visual as shown in Figure 3(b).

Figure 3: Flight track of snapshot image at height (a) 2-5 meters and (b) 30 meters from the surface

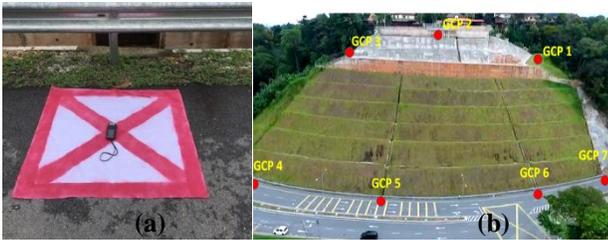
To get the coordinates and the altitude more accurate Global Positioning System (GPS) GPSMap 78s model is used as shown in Figure 4(a) to facilitate the work of decision-ordinates. There are coordinates of Ground Control Point (GCP) as the control point on the ground. 7 GCP required in this work so that 3-dimensional images can be generated accurately as shown in Figure 4(b).

Figure 4: Placing GPS Map 78s at the location of Ground Control Point

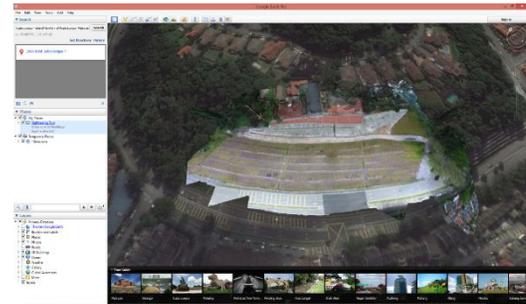
Figure 7: Location in the Study Area In Google Earth Pro

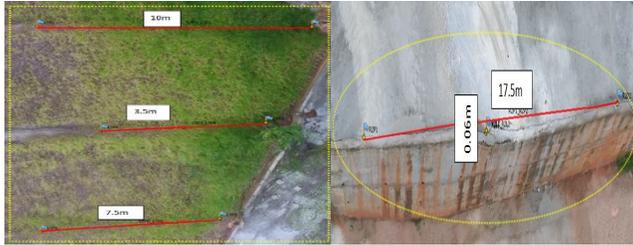
slopes of cracks, cover plants and sediment. There are two cracks were found, one in the concrete wall and another ground cracks. In fact, there are two settlement prevailing happen on soil. In addition, the plant cover also the damage that has been found. All the damage was combined and produces a 3D model where each is shown in Figure 8-12.

Figure 8: Damage Analysis of 3D models Vegetation Coverage

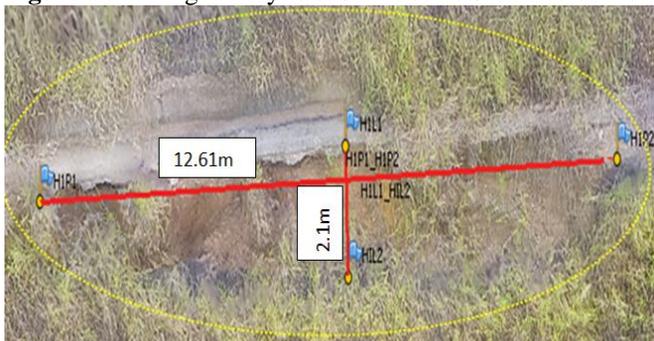
Figure 12: Damage Analysis of 3D models Soil Erosion No 2

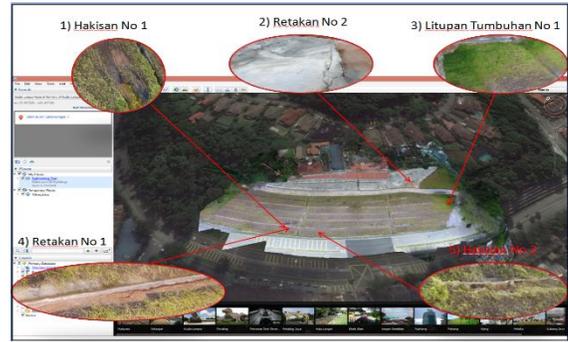
All the 3D damaged model are linked to the overall structure of a 3D model of the slope using Google Earth Pro software, as shown in Figure 13. Finally, the coordinates of the damage can be identified from google earth pro, as shown in Table 2

Figure 13: Damage position at The Slope Structure in Google Earth Pro
