## Quantitative Infrared Thermography Resolved Leakage Current Problem in Cathodic Protection System

### ABSTRACT

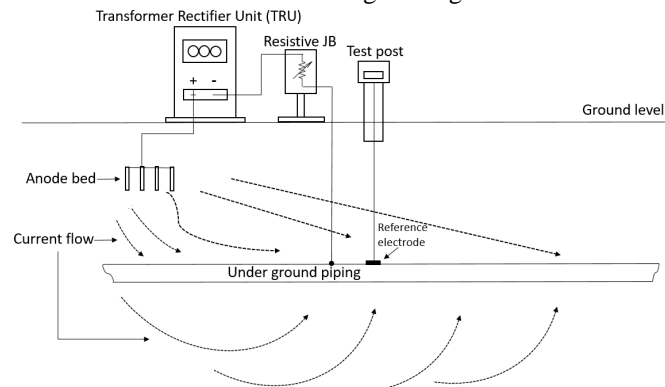
**Figure 1:** ICCP system diagram

The incident is about new commission of CP system unable to achieve protective level causing live underground piping without protection against corrosion. The mentioned problem observed at lube base oil plant on 14<sup>th</sup> June 2016. Weather condition is good and fair morning. Investigation method applied is Kepner Tregoe hybrid with Tripod Beta. Configuration of related CP system is ICCP with maximum load 42A<sub>dc</sub> as can be seen in diagram Figure 1 below.

In this method, an external DC power source is supplied from rectifier fed from an AC supply as shown in Figure 1 above between the cathode and sacrificial anode. This method is more efficient for long distances and covering large areas. The anode used is more effective and able to protect long objects. Also, it is very flexible in dealing with soil resistivity variations, because it is capable to supply various required current [16][17].

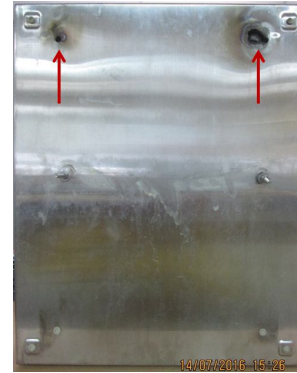
**Figure 2:** Rear side enclosure

- 1) Found two holes (refer red arrow) as effect of localize burning on the top of resistive junction box enclosure at rear side. The junction box made of stainless steel with code SS304. Refer Figure 2 below.

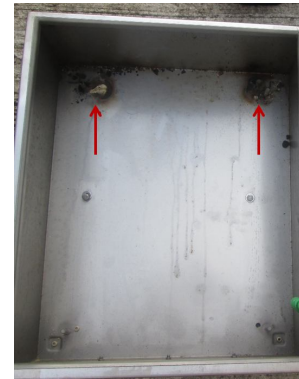
**Figure 3:** Inside enclosure

- 2) Observed two holes (refer red arrow) as effect of localize burning on the top of resistive junction box inside enclosure (as can be look from front access). Refer Figure 3 below.

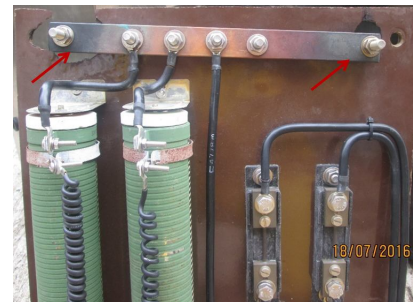
**Figure 4:** Heating sign on copper busbar

- 3) Heating sign on right and left portion of copper busbar (refer red arrow). Copper busbar act as nodal point for electric current distribution between negative terminal of CP TRU and adjustable resistors. All said components being mounted on Bakelite board (brown color). Refer Figure 4 below.

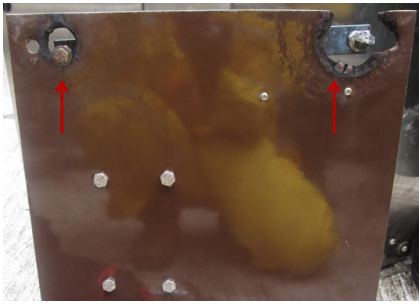
**Figure 5:** Burning at rear side of Bakelite

- 4) Burning sign (refer red arrow) on back side of Bakelite board at the portion perpendicular with heated copper busbar. Round shape vanished as effect of burning. Refer Figure 5 below.

It can be seen that the Bakelite mounting board has lowest melting temperature among all. Meaning, there is something happened that produced heat at temperature more than Bakelite’s melting point. The immediate facts and findings shown before couldn’t lead us straight forward to the real root cause of the problem. Hence, the systematic approach with assistant of IRT method seems as an alternative way forward.

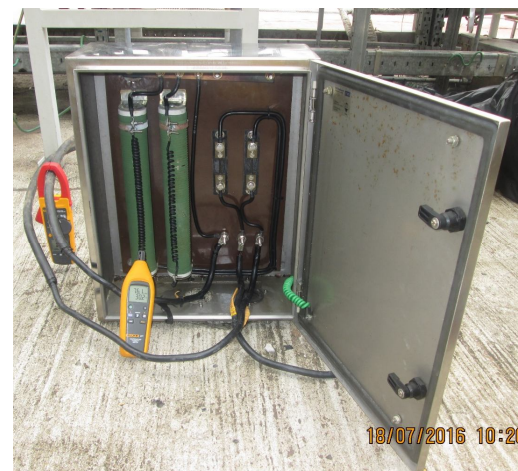
**Figure 7:** Experiment setup at site

Experiment was setup as per original installation configuration at site. All cablings related to ICCP system were being wired and terminated properly as normal operation. In addition, suitable clamp meter, temperature detector and humidity detector being hooked-up at the best point those could captured or recorded most actual surroundings intended parameters. The said parameters are surrounding temperature, surrounding humidity, ICCP loading current and thermal image temperature inside the

resistive junction box. Once all requirements full-filled and in correct position, it is about to energize power supply and put the ICCP system as real normal operating condition. Setup experiment arrangement as Figure 7. Our assumption for this experiment is surrounding temperature and humidity about same or very slight changes. Also, it must shield from external source of radiation. Because of probing surface temperatures of the sample, it is inevitable closely related to heat flows. Nonetheless, heat flow is closely linked to energy use. In conjunction, other thermal characteristics such as thermal comfort and condensation also linked to surface temperatures [33]. So, these are a few factors to be fixed. Also, it is necessary to prevent surface condensation, which will alter surface emittance and affect performance [33]. In one journal stated the possibility to know the temperature under influence of leakage current that will appear in thermogram later. This new derived equation tells us that the infrared net radiation power is proportional with leakage current, materials resistance, time to reach temperature equilibrium as well as emissivity of the object. But inversely for weight and specific heat capacity of materials. It is presented as (1) below [15].

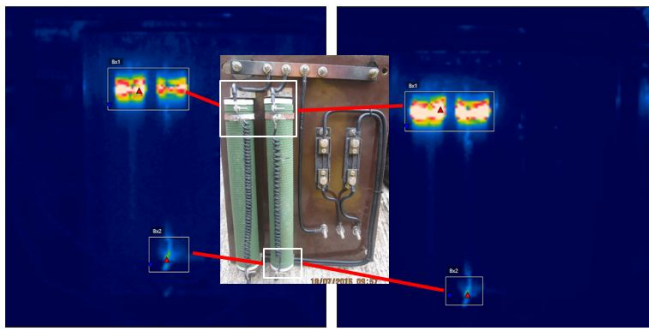
Figure 8: Thermogram inside resistive junction box

Once the ICCP system back on-line, the variac resistance located at CP TRU being rotate or tune in stages from 0Adc until reach 10Adc loading. Testing and checking inside resistive junction box. Then, maintain for a few minutes for capturing thermogram related and log in parameters as mentioned in the earlier section. Next, the current loading being increase gradually to maximum loading which is 42Adc. This step is important as to simulate as much as similar to actual operating condition and to reveal the hot spot area on the resistive junction box. Two significant area to be investigated are area inside resistive junction box (front access) and its rear side (rear access). All visual results as well numerical shown in Figure 8 & 9 and Table 5 & 6 follows.

No.	Load (A)	Thermogram Temperature (°C)					
		Box 1			Box 2		
		Min	Max	Ave	Min	Max	Ave
1.	10	33.6	110.5	52.5	31.8	52.2	35.3
2.	42	35.9	150.2	81.8	32.4	74.8	38.5

Due to the temperature rise quite high up to 150°C during 10Adc loading and considering the safety at process area; hence we just conduct the simulation for 10 seconds only. There is a sign of component overheating i.e. adjustable resistor. This showing the high probability of components under rating i.e. adjustable resistor. Due to short duration held for the simulation, we cannot see the heating effect at the copper busbar as well at Bakelite board. We could make inference that the copper busbar and Bakelite board will get heated and lead to insulator bushing melted as in Figure 10.

- To revisit the selection rating for adjustable resistor as well quantity to accommodate the CP load current comply with CP TRU rating i.e. 70A for safe and reliable operation.

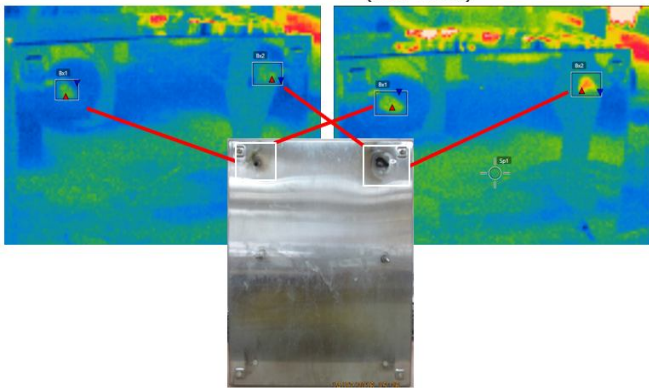
Figure 9: Thermogram rear side resistive junction box

No.	Load (A)	Thermogram Temperature (°C)					
		Box 1			Box 2		
		Min	Max	Ave	Min	Max	Ave
1.	10	30.2	32.5	31.5	30.0	32.6	31.6
2.	42	30.5	33.1	31.8	31.2	36.0	32.6

The slight temperature difference and increment at overall from 10A load to 42 A load (as well compare to surrounding temperature) signifying that there is a leakage or circulating current flowing through the junction box enclosure surface. Please note that due to short duration held for the simulation, we cannot see the great heating effect by the flowing of current. 2 numbers of temperature spot detected showing the area of a bit high current intensity. The right side (Box 2) could be consider as drain/sink point due to higher temperature compare to left side and return point at the left side (Box 1). This finding in-line with the burning condition of the junction box enclosure where the right side (Box 2) had a bigger of hole size compare to left side (Box 1).

- To use non-conductive electrical bolt (that mount the copper busbar onto the Bakelite board) to avoid any leakage/circulating current phenomenon through the junction box enclosure in case of the insulating bush degraded/damaged in the future.

- To increase the distance between bolts (that mount the copper busbar onto the Bakelite board) and junction box enclosure by installing dual numbers of insulating bush or equivalent means those could serve the same purpose.

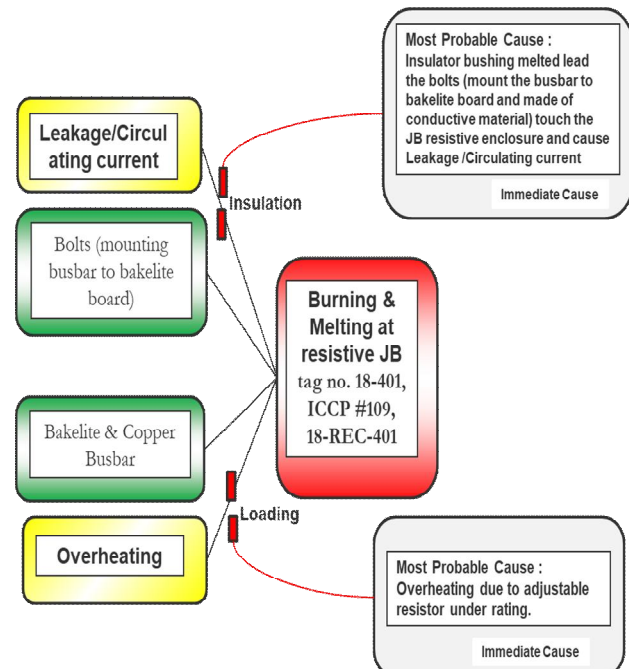
**Figure 11: Tripod Beta diagram**

For the purpose of reaffirmed or retest our hypothesis, we can use another method root cause failure analysis such as Tripod Beta. Based on the results on the checking and simulation we could synergize all the data, evidence obtained and arranged them into form of Tripod Beta in Figure 11.
