Selected Melaka Malay traditional houses: comprehensive analysis on building defects, failures and solutions

1. MR ABDULLAH BIN MANSUR'S HOUSE

2. MR BUJANG SIAM'S HOUSE

3. TUAN HAJI HUSSIN BIN LAJIS'S HOUSE

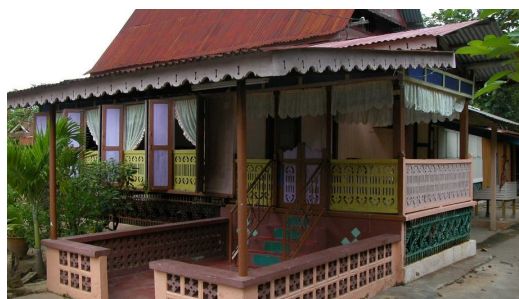
Figure 10(a): House of Bujang Siam

Refer to Figure 10(a) and 10(b), this house is located at No. 861, Perigi Hang Tuah, Km. 6, Kampung Duyong, Melaka. It was built in 1961 at a cost of RM 5,000. The house has twelve columns and can be categorized as a building which has two houses detached to it with a long roof on top. The house comprises of a front porch or veranda, an annex, the main house, the middle house, two bedrooms and a kitchen. The difference of this house with other traditional Malay house is that it does not have a “*selang*”, which is a passageway that connects the kitchen to the main house. The middle house has taken over the function of the “*selang*”, where the women guests were welcomed.

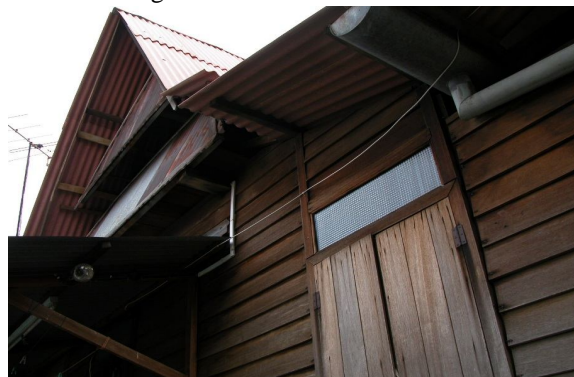
Figure 17: House of Mr Haji Hussin Bin Lajis

Refer to Figure 17, the house was built in 1960 and occupied by him after completion of its construction in the same year. Although this house is categorized as the Melaka Malay traditional house with 16 stilts, the owner still wanted to have slight difference from the others and also to realize his dream of having distinctive elements in his house.

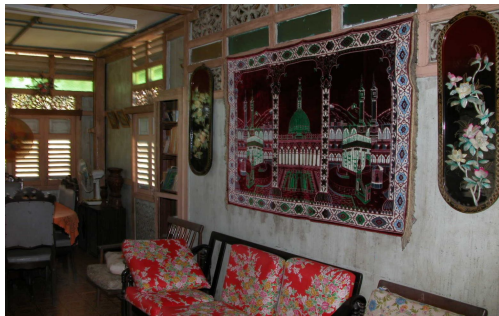
Figure 23: House of Mr Haji Johan

Refer to Figure 23, he built this house in 1964 and the house is an addition to the back of the house that he built in 1960. Haji Johan has built this house with his own effort for one year by using similar types of wood. He worked from morning until night to build the front part of his house. All carvings that were found in the house had been carved by Mr Haji Johan and he usually takes only one day to complete one small detailing carving. In the beginning, the front part of the house was built as a shop that was rented by a Chinese boss.

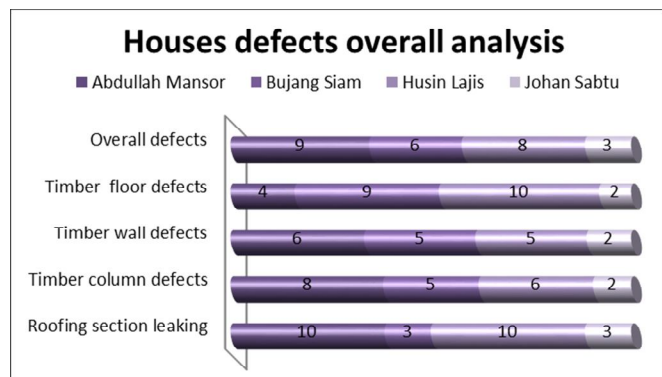
From the result of the visual finding, it can be concluded that the external factor affecting standard or historical traditional buildings especially those located in the case study location; Melaka are due to climatic change, air pollution, and lack of maintenances (see Fig. 34 below). Climatic condition is the act of atmospheric event such as rainfall, temperature, air pressure and humidity [1]. Due to the tropical climatic condition, Malaysia has heavy rainfall and warm sunshine all year round. Therefore the external part of the building tends to weather rapidly [5].

Figure 34: The above chart shows the overall analysis of the house defects based on the type of defects and level of seriousness.
