Selected Melaka traditional houses: comprehensive analysis on building defects, failures and solutions including the Chetti house

Key words: building defects, construction failures, building leakage, Malaysia.

1. MALACCA CHETTI ASSOCIATION HOUSE

2. MRS KASMAH BINTI YASSIN'S HOUSE

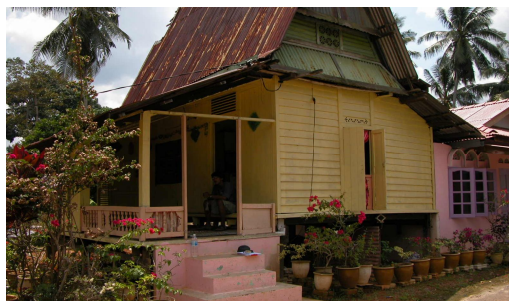
Figure 9: House of Mrs Kasmah Binti Yassin

Refer to Figure 9, this house was built by Mr Yassin 60 years ago. It is located at Kilometer 6, Perigi Hang Tuah, Melaka. It can be categorized as a building which has three houses detached as one with sixteen pillars. The shape of the roof is a long roof. The design of the space comprised of a porch, the main house and the passageway that connects the kitchen to

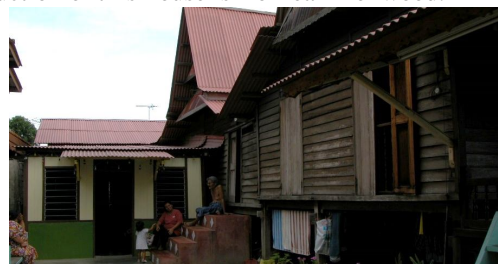
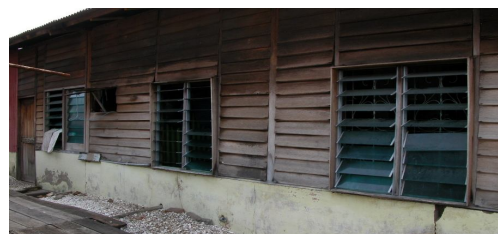
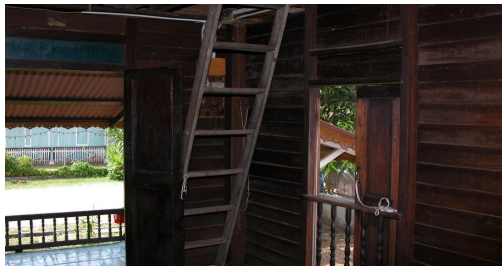
Refer to Figure 27(a), 27(b) and 27(c), the house is composed of 12 pillars which support the house strongly from the beginning until today. The house as a whole is using wood as the main building material. Mr Umar bin Ali is now in his late 80s and he built his house in Kampung Morten on his own. His father had hired a handyman to build the house. There are some parts that have been modified using the material of stone, which is the kitchen. Most of the wood used in the construction of this house is Bornean ironwood.

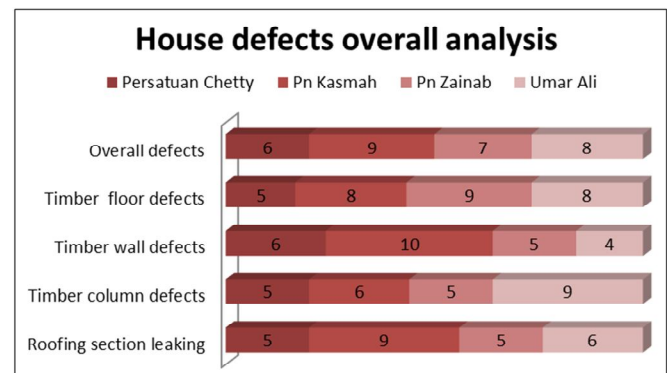
From the result of the visual finding, it can be concluded that the external factor affecting standard or historical traditional buildings especially those located in the case study location; Melaka are due to climatic change, air pollution, and lack of maintenances (see Fig. 35 below). Climatic condition is the act of atmospheric event such as rainfall, temperature, air pressure and humidity [1]. Due to the tropical climatic condition, Malaysia has heavy rainfall and warm sunshine all year round. Therefore the external part of the building tends to weather rapidly [5].

Figure 35: The above chart shows the overall analysis of the buildings based on the defects level of seriousness.
